Structural Hazards of Smouldering Fires in Timber Buildings

By Harry Mitchell

Mass Timber Compartment Fire Experiments

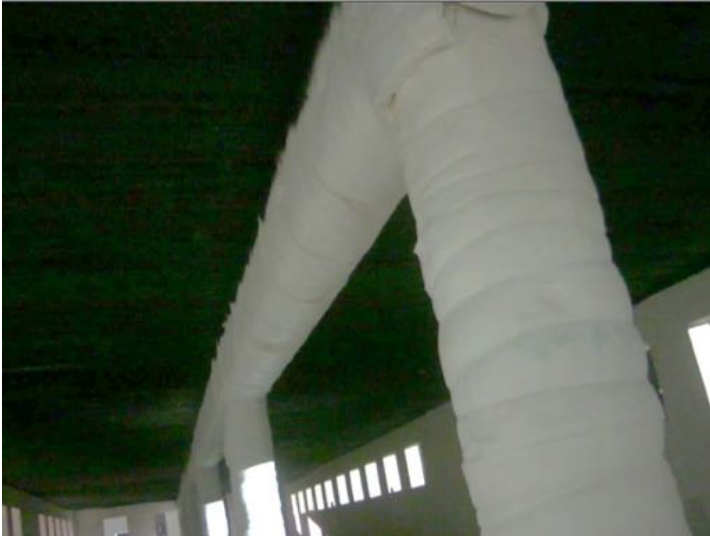
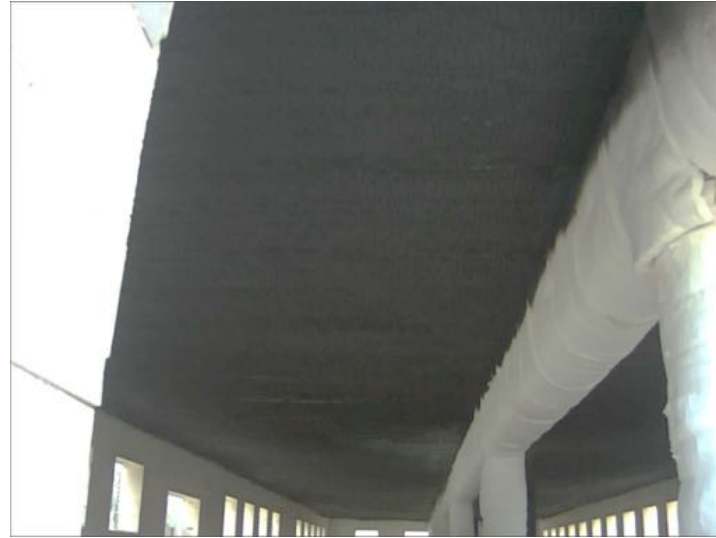
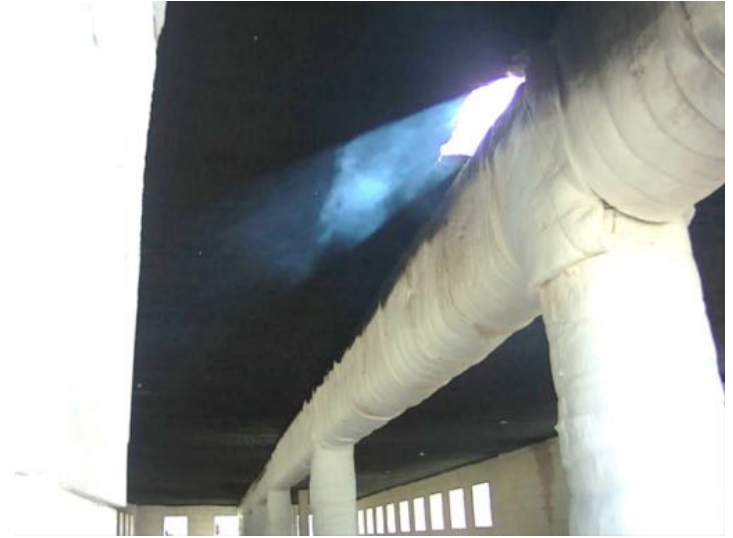
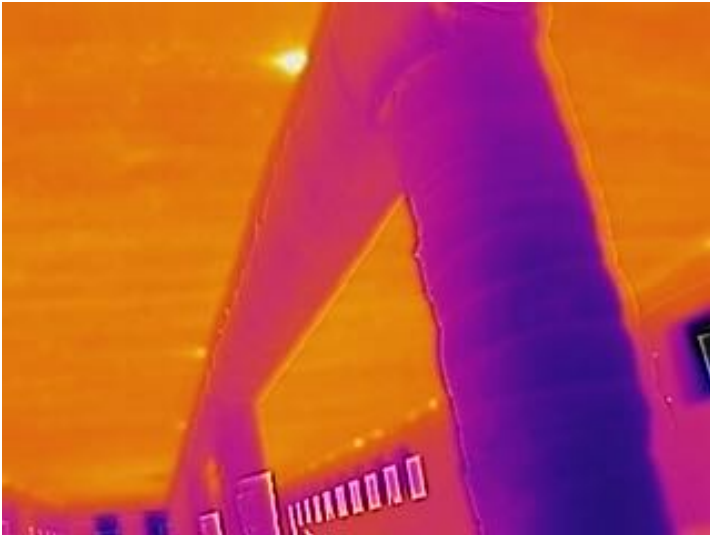
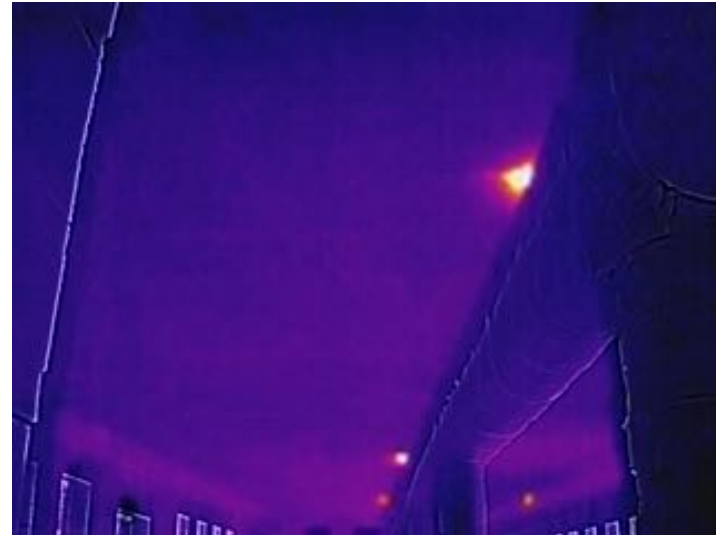
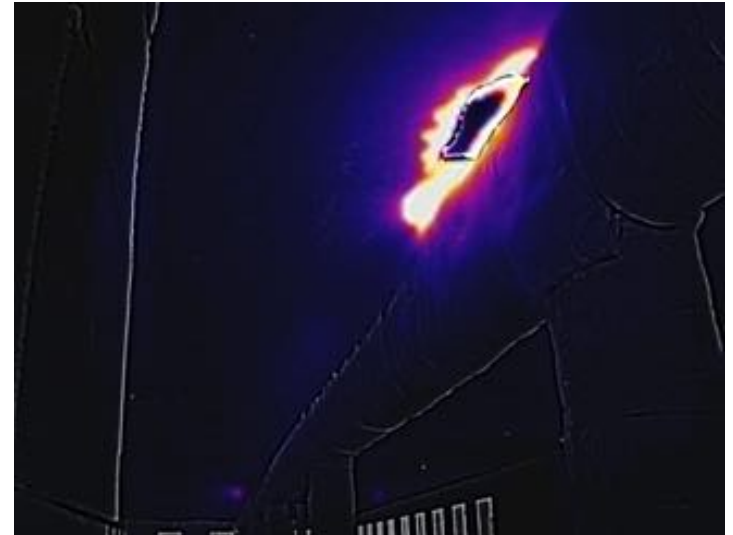
Tracking smouldering

t = 3.18h

t = 14.28h

t = 38.08h

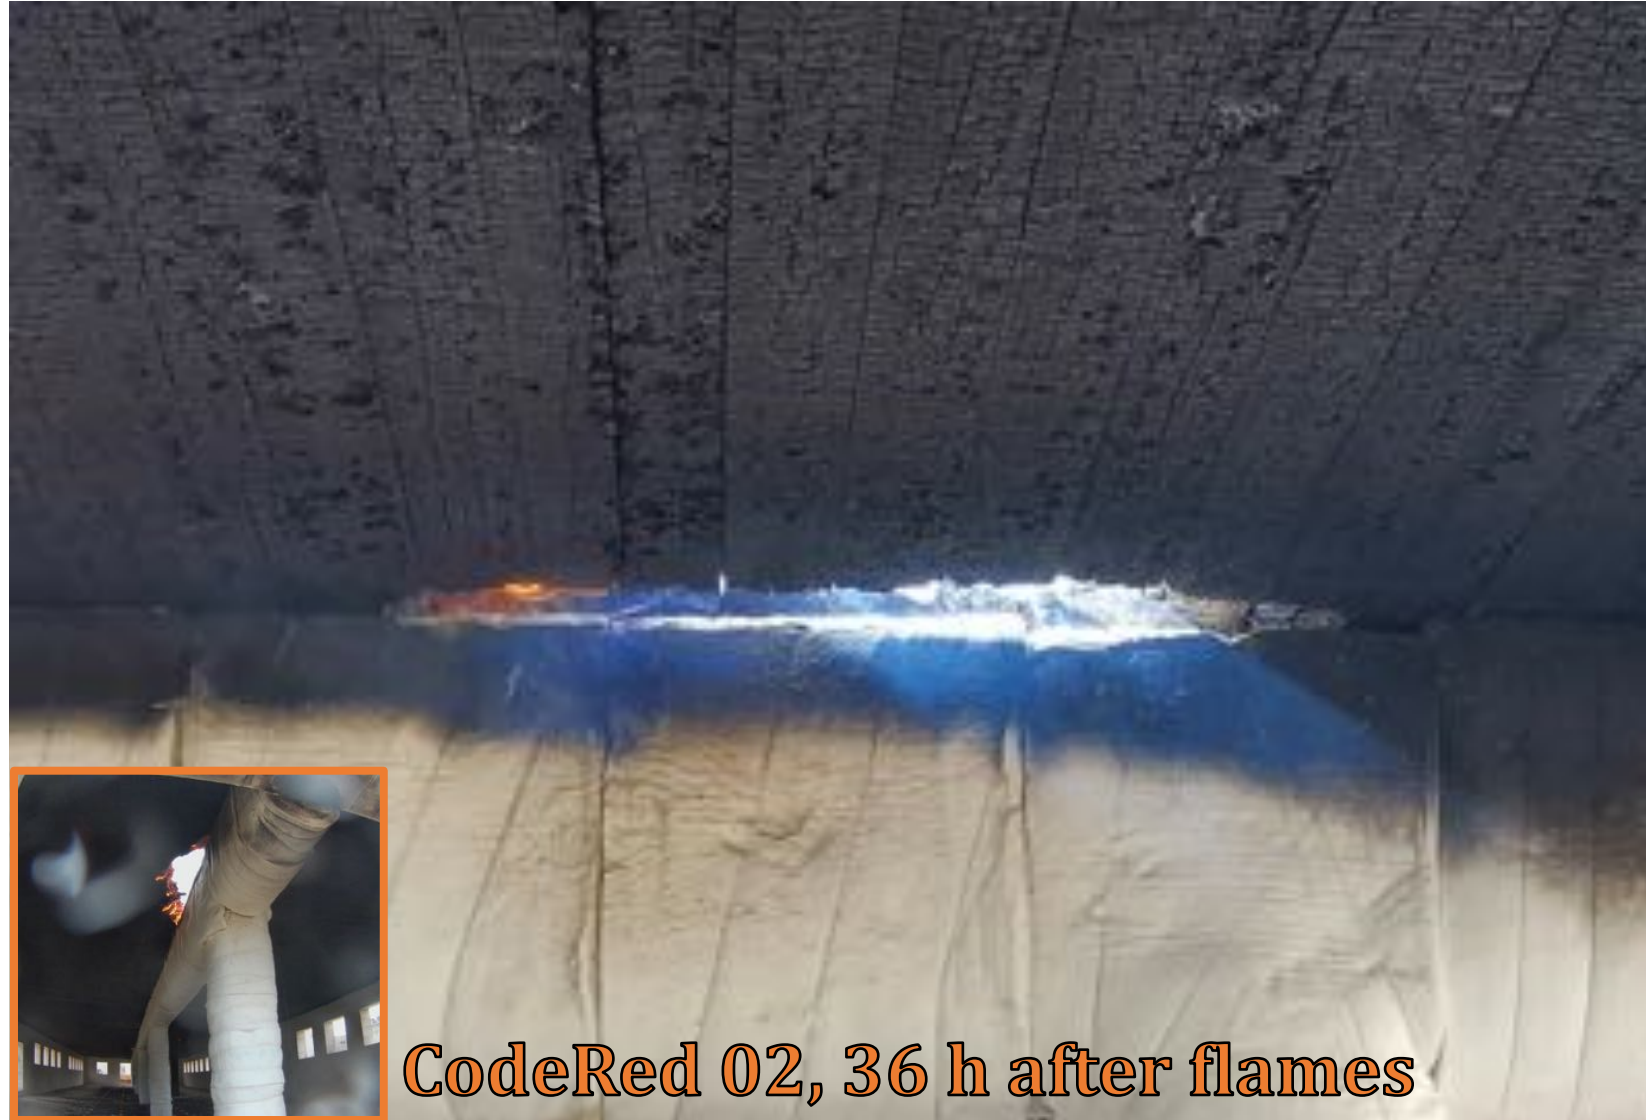
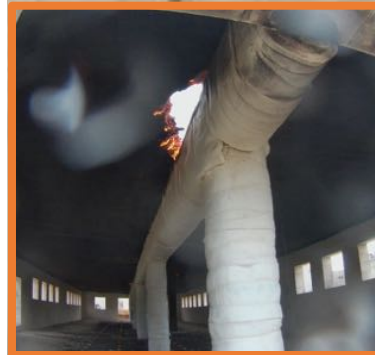
CodeRed 02, 36 h after flames

Flaming observed at hotspots hours after fire

Transition to flaming can present a hazard (starting a new fire!)

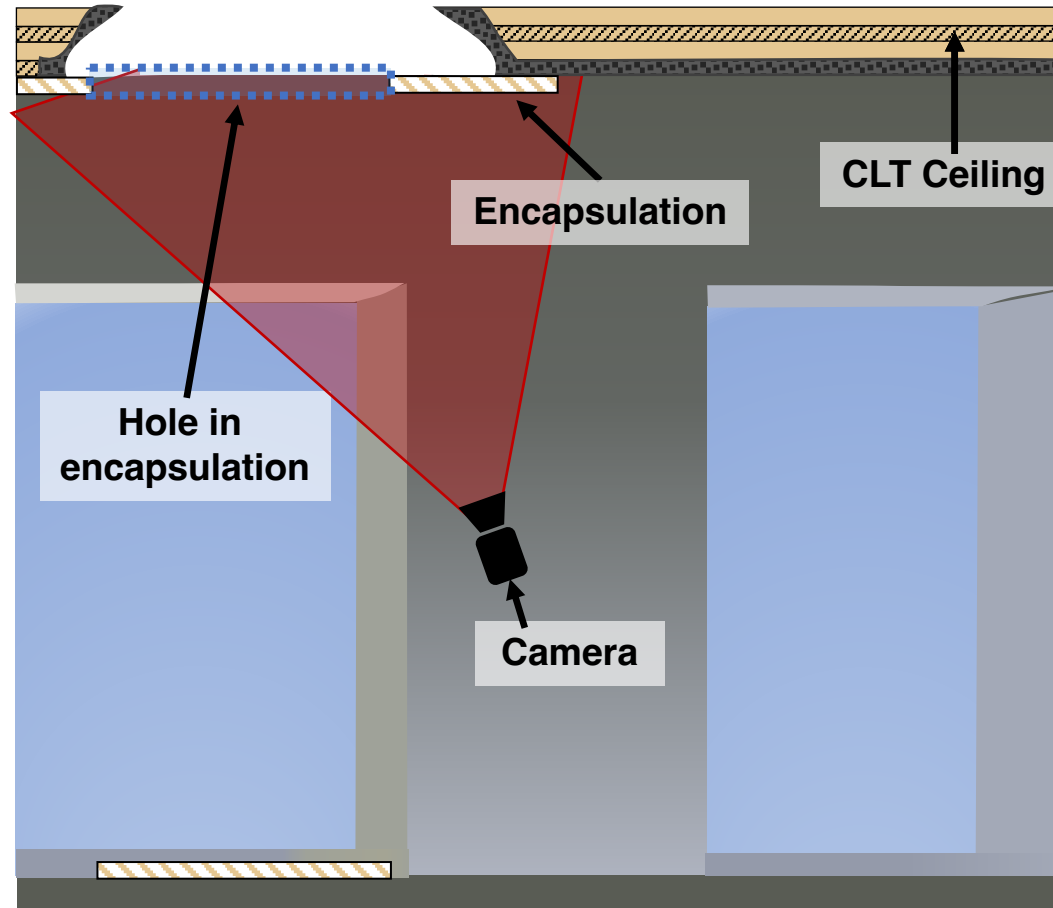
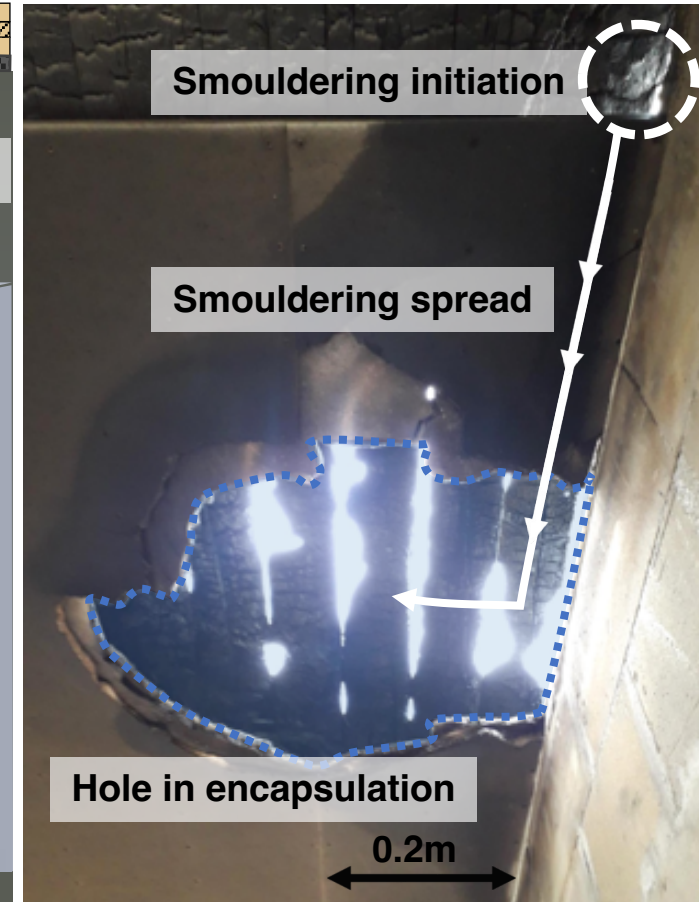
Encapsulation - Hidden fires!

✓ No smouldering detected under protection over 48h following the end of flames.

⚠ After 22 days, encapsulation fell through, exposing hole in CLT.

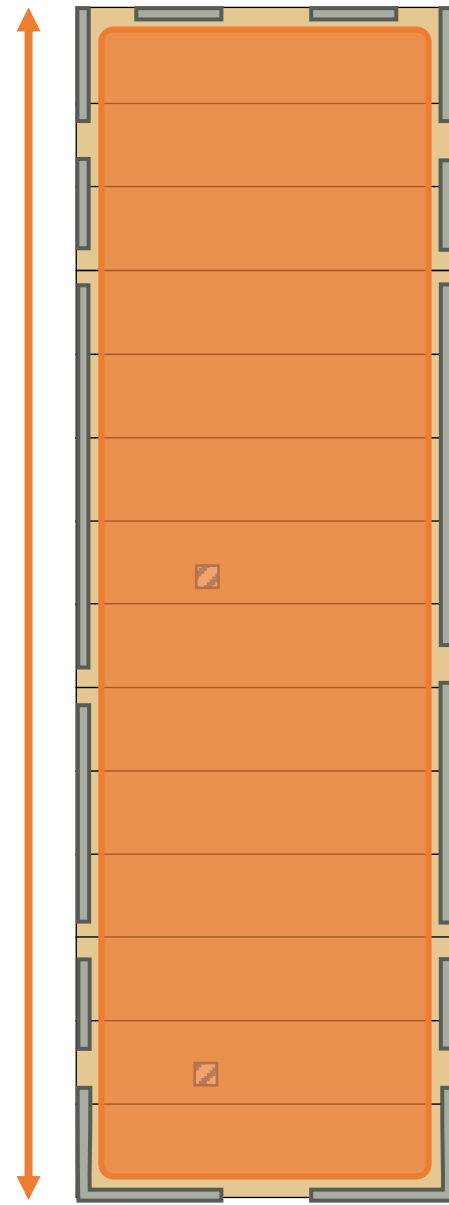
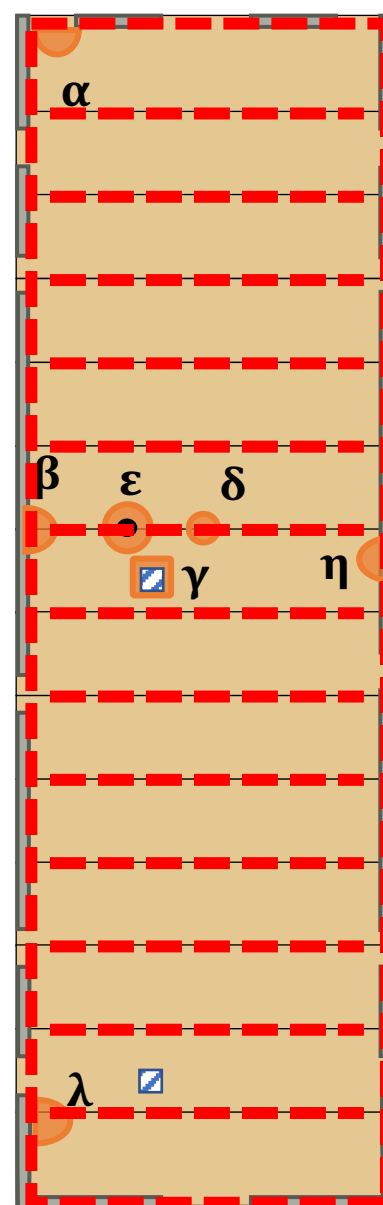
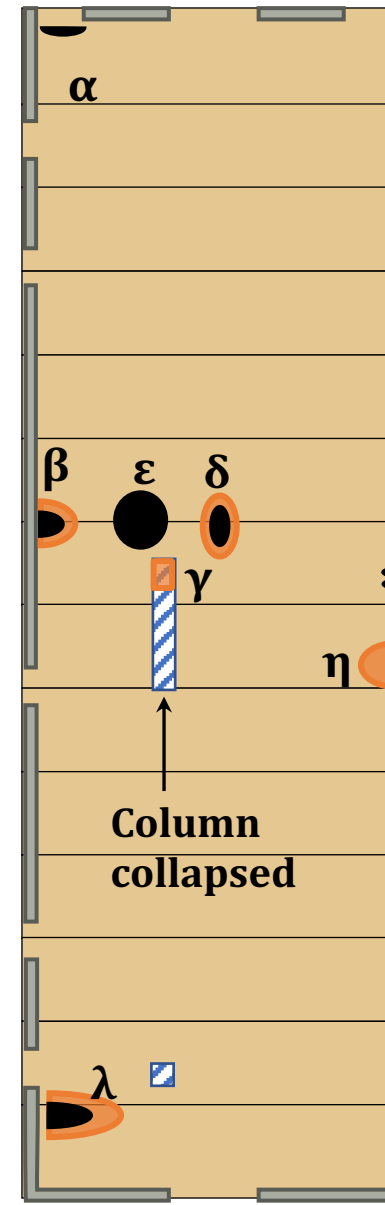
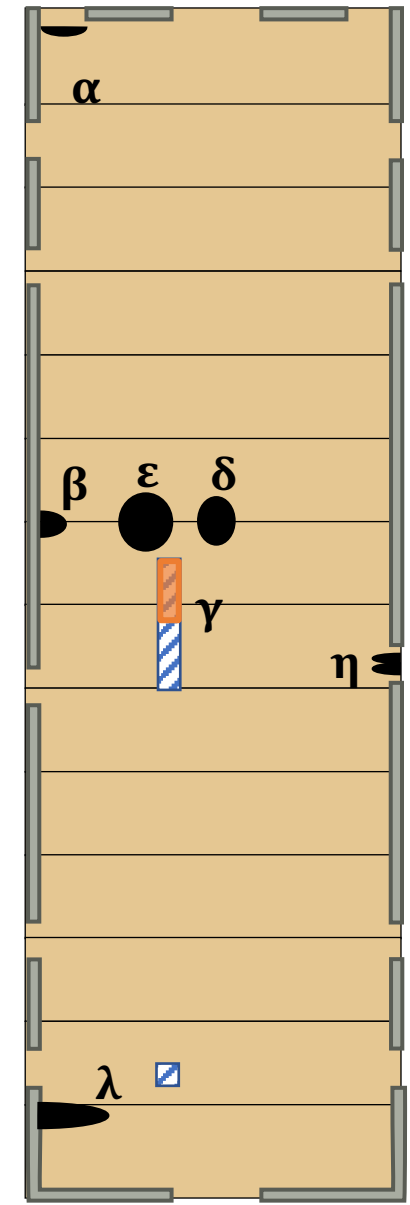
CodeRed #02

$t \approx 0h$ (after flames)

$t \approx 12h$

$t \approx 36h$

$t \approx 60h$
