# Damage assessment, residual cyclic behaviour and repair of fire-exposed reinforced concrete columns

*Preliminary experimental results from fire resistance & residual cyclic loading tests*

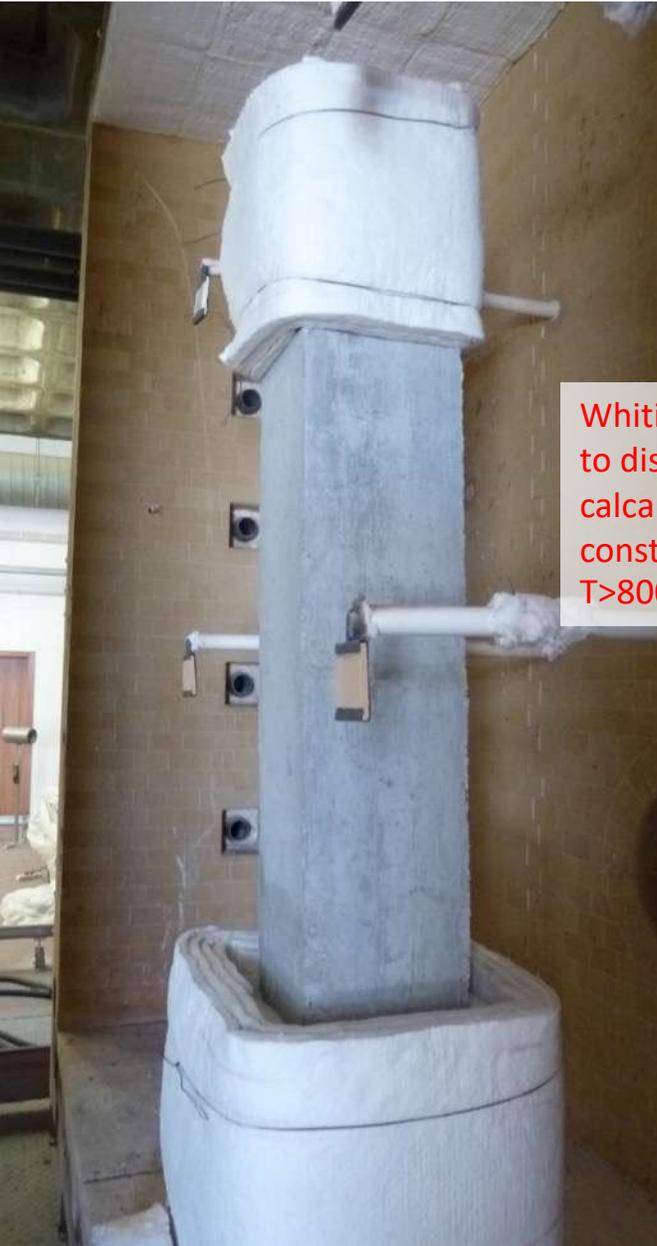
Whitish corners due to disintegration of calcareous constituents at  $T > 800^{\circ}\text{C}$

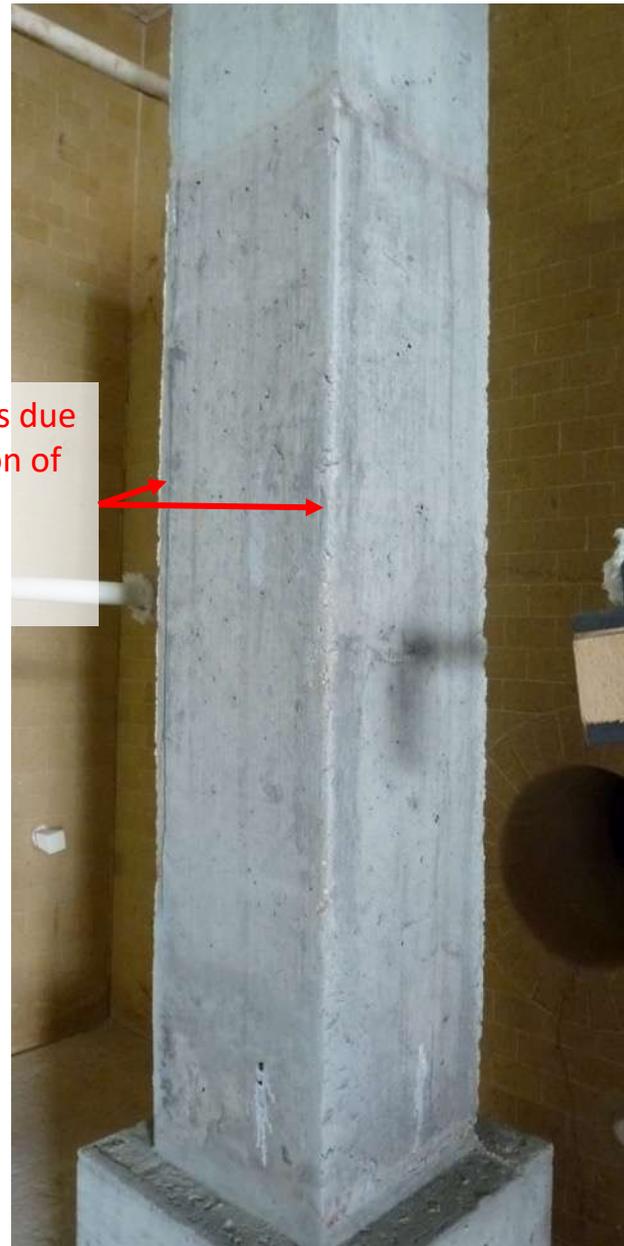
Moderate crazing on cement paste

Visible transverse & longitudinal cracks near melted spacer

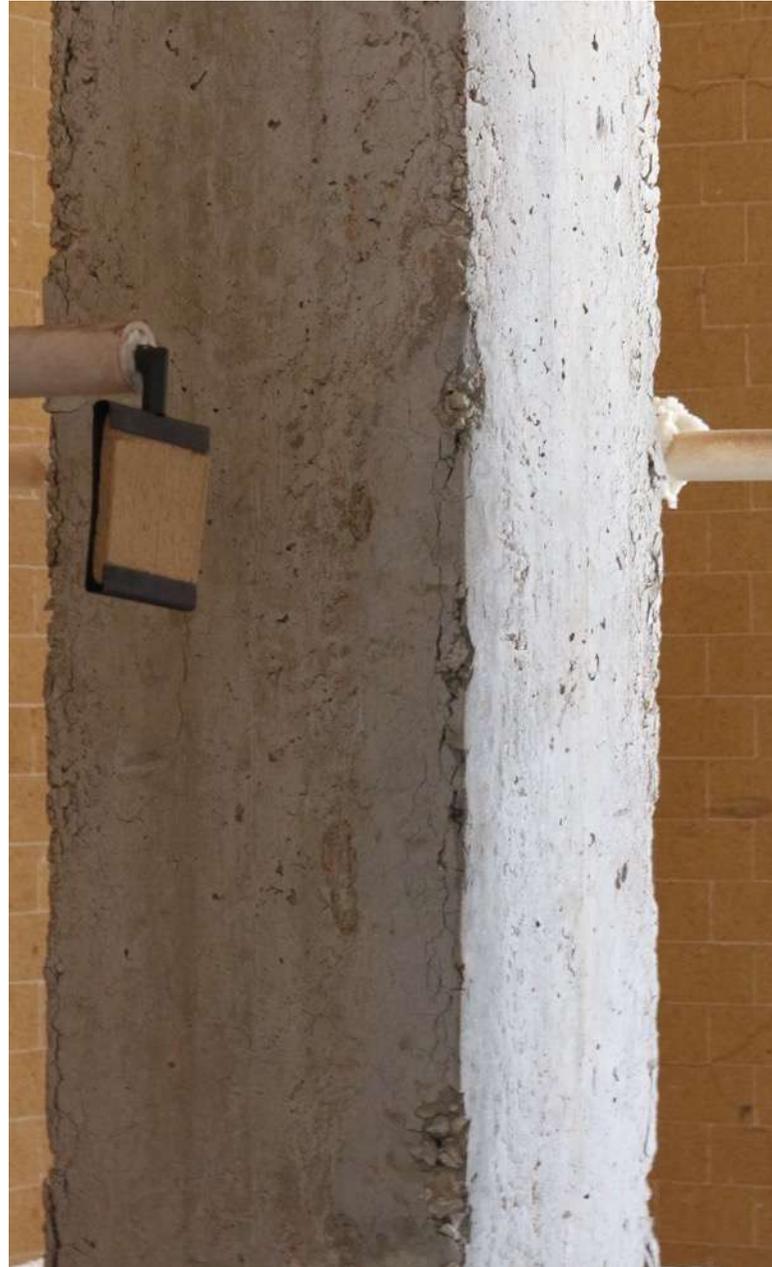
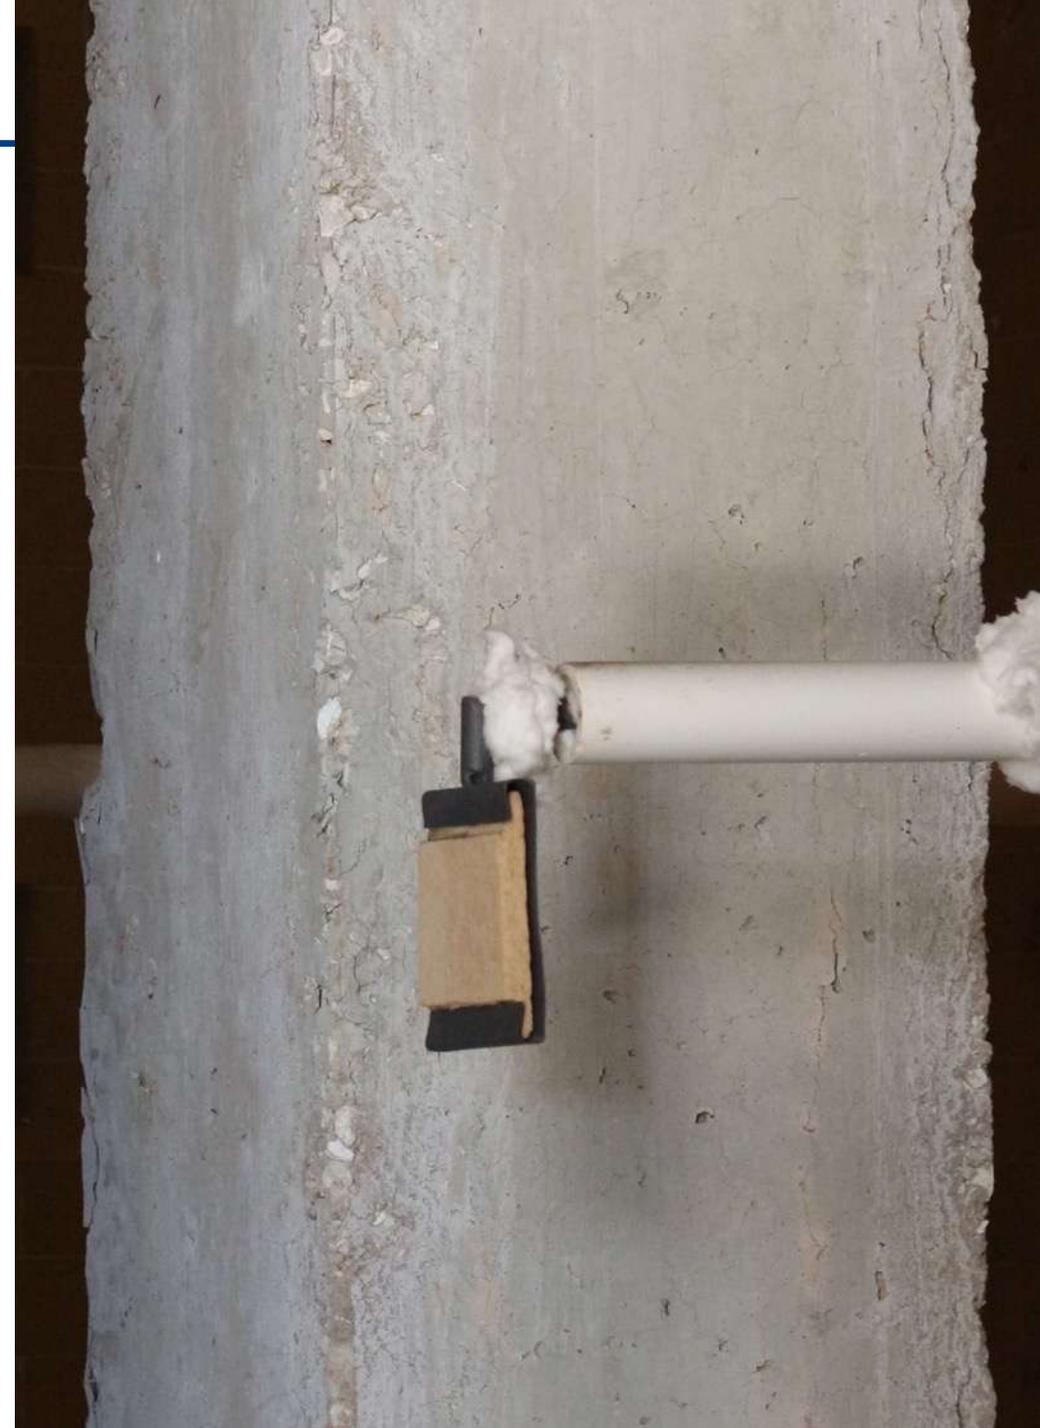
- Extensive crazing
- Heavily cracked corners
- More extended whitish-grey concrete zones
- Very localised spalling at corners

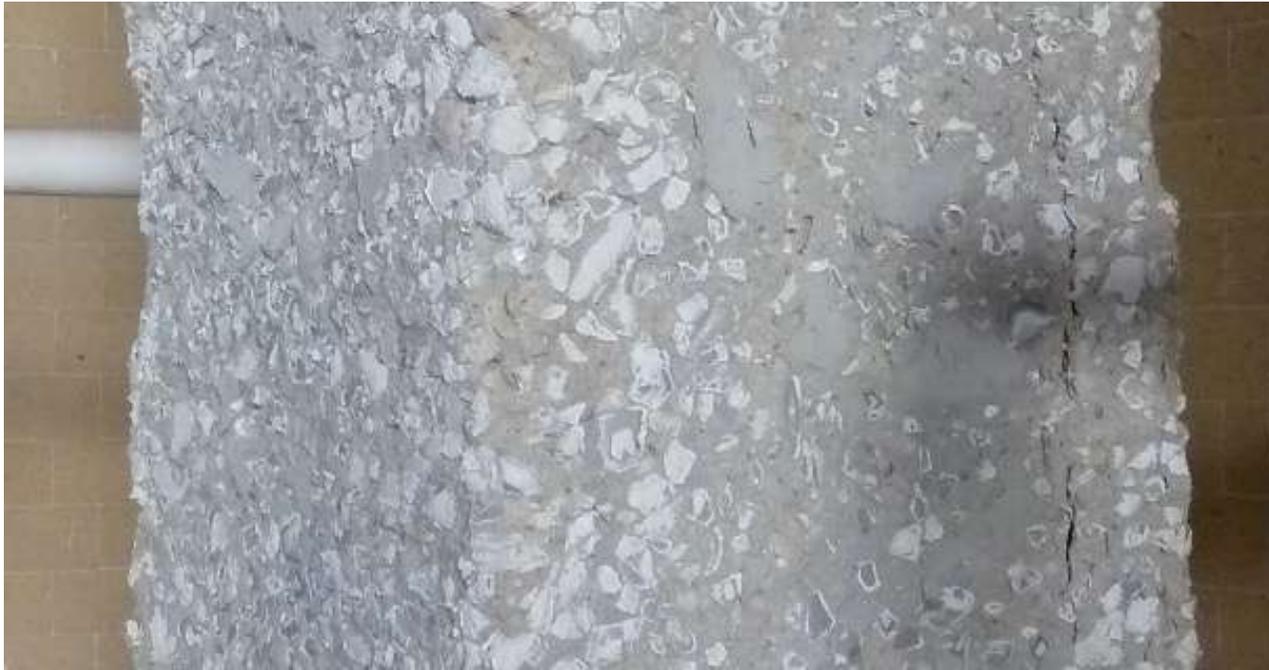
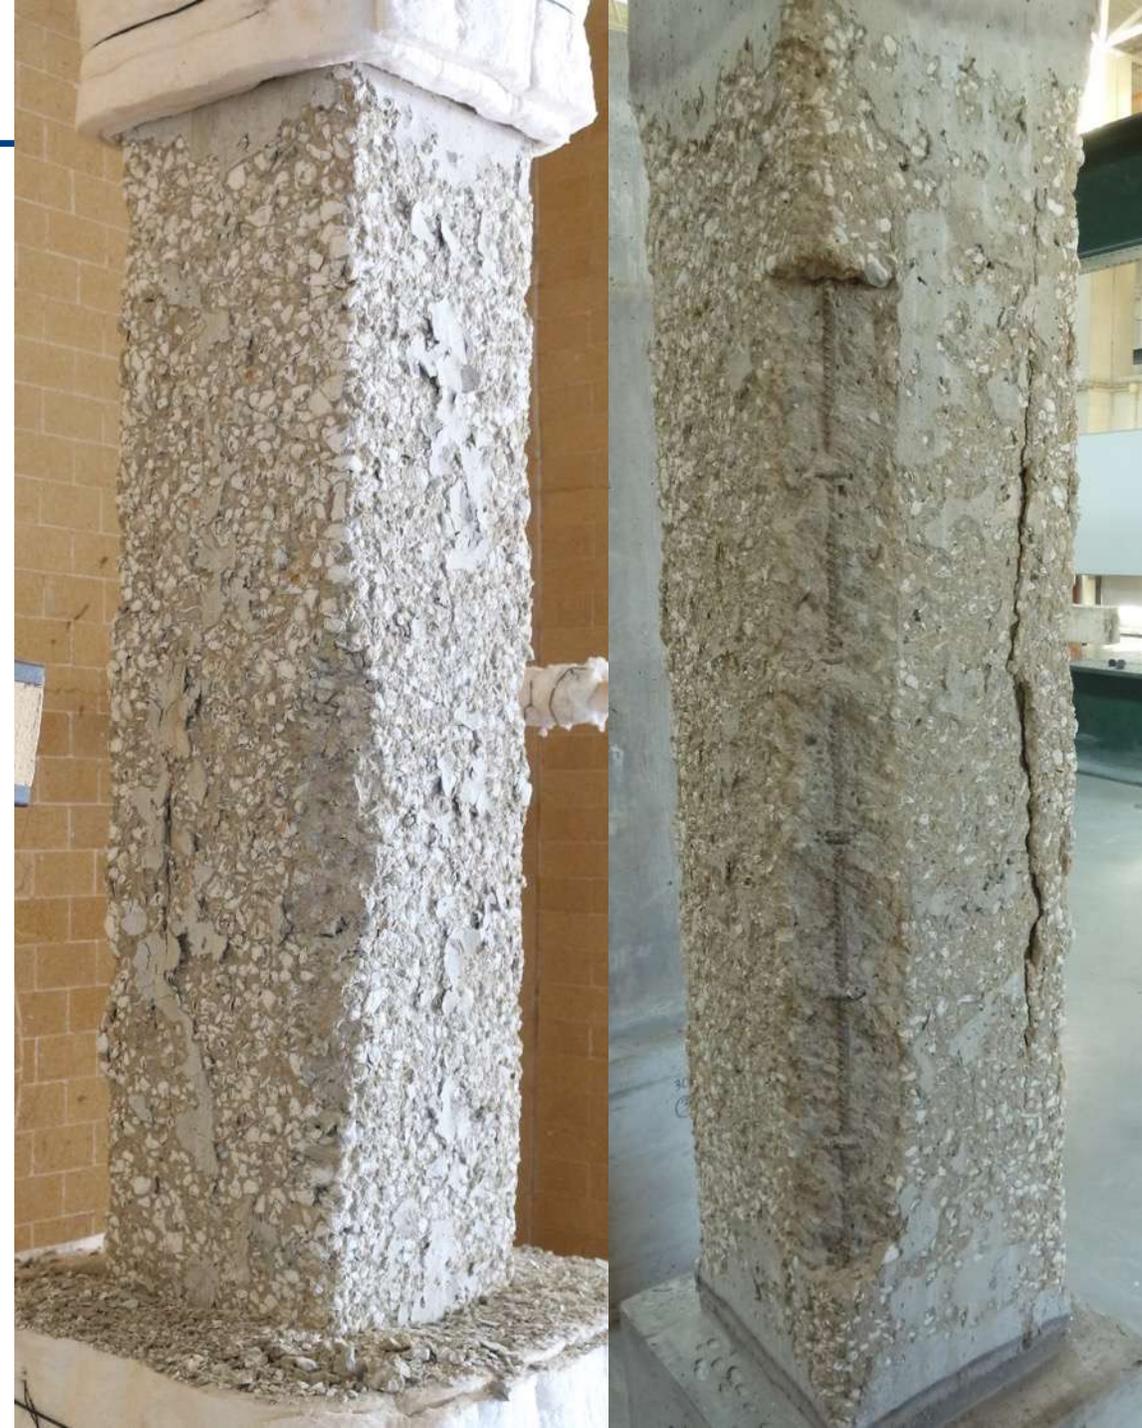
- ~1-2cm of outer concrete layer flaked and popped off:
  - limestone aggregates (and calcium carbonates in cement) turned into calcium oxide at  $\sim 825^{\circ}\text{C}$
  - Upon rehydration after the fire test, the CaO aggregations react with water to form  $\text{Ca}(\text{OH})_2$ , they crumble/disintegrate and fall off

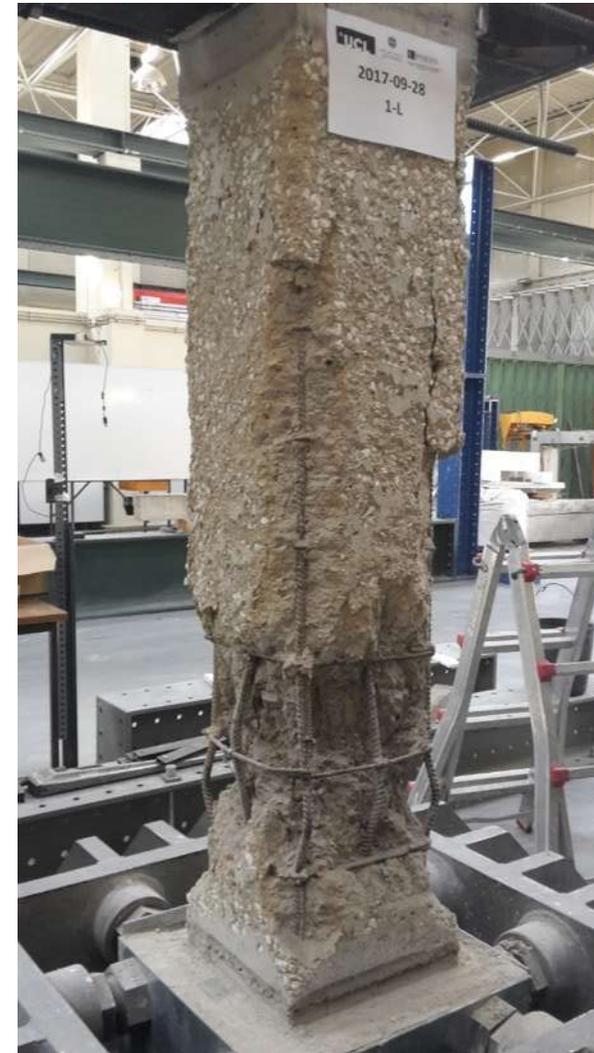
*90min ISO834 column*

- Plastic deformation spread over larger length;
- larger buckled length of rebars due to stirrup opening;
- concrete core completely damaged

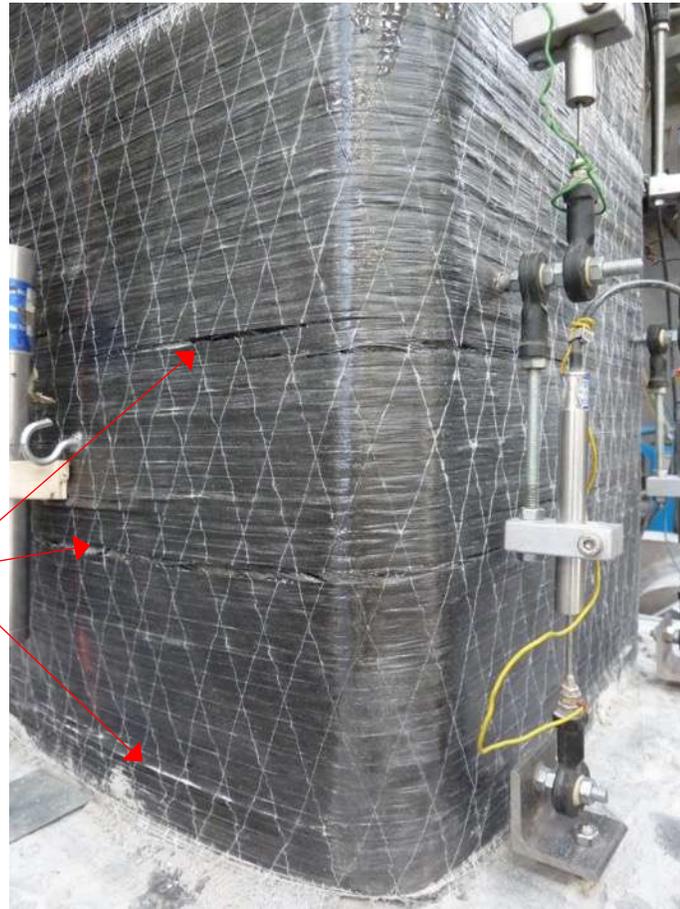
Flexural cracks between transverse unidirectional carbon fibres

Bulging due to middle rebar buckling
