STRUCTURES IN FIRE FORUM

REUSE OF WASTE TYRE FIBRES FOR FIRE SPALLING MITIGATION

DR SHAN-SHAN HUANG

12/04/2016 @ IStructE HQ, Bastwick Street, London

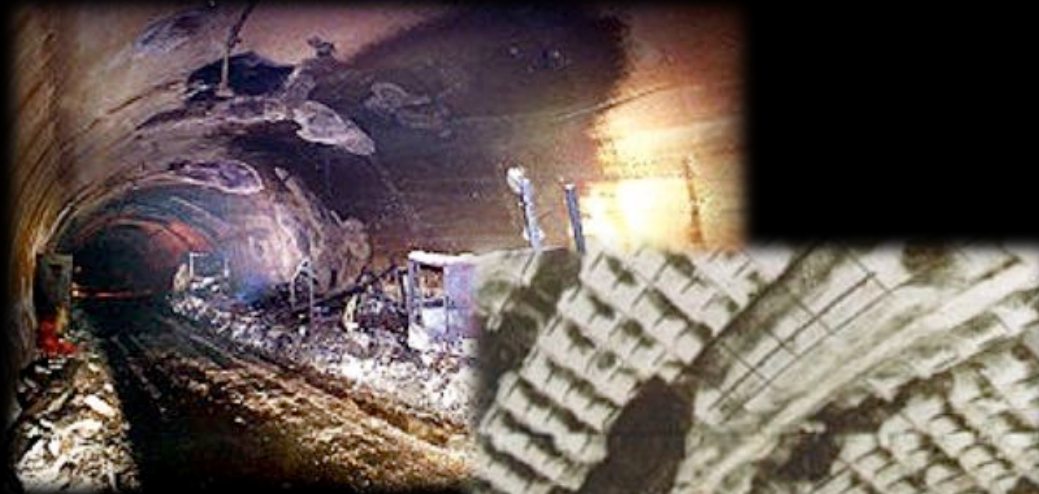
Mont Blanc tunnel after fire
Source: www.phys.tue.nl/

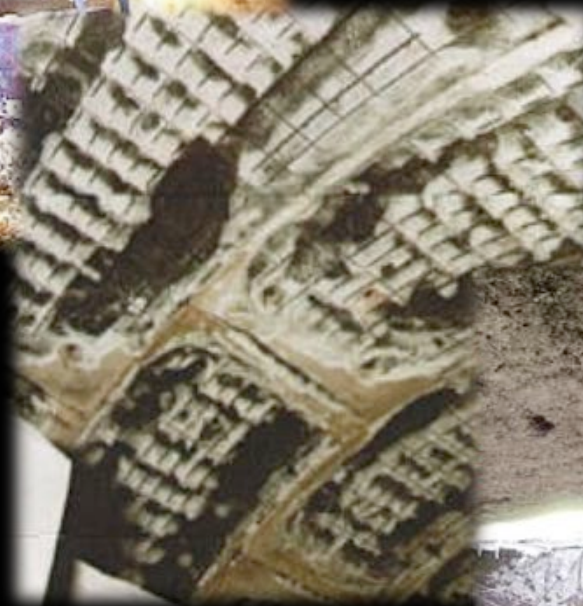
Channel Tunnel fire
Source: www.phys.tue.nl/

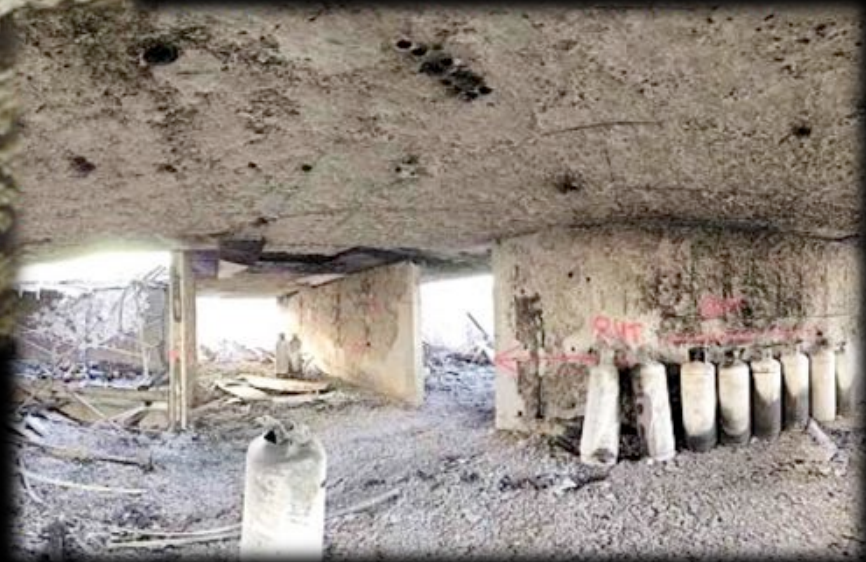
Spalling of a building under construction
Source: www.panoramafactory.net

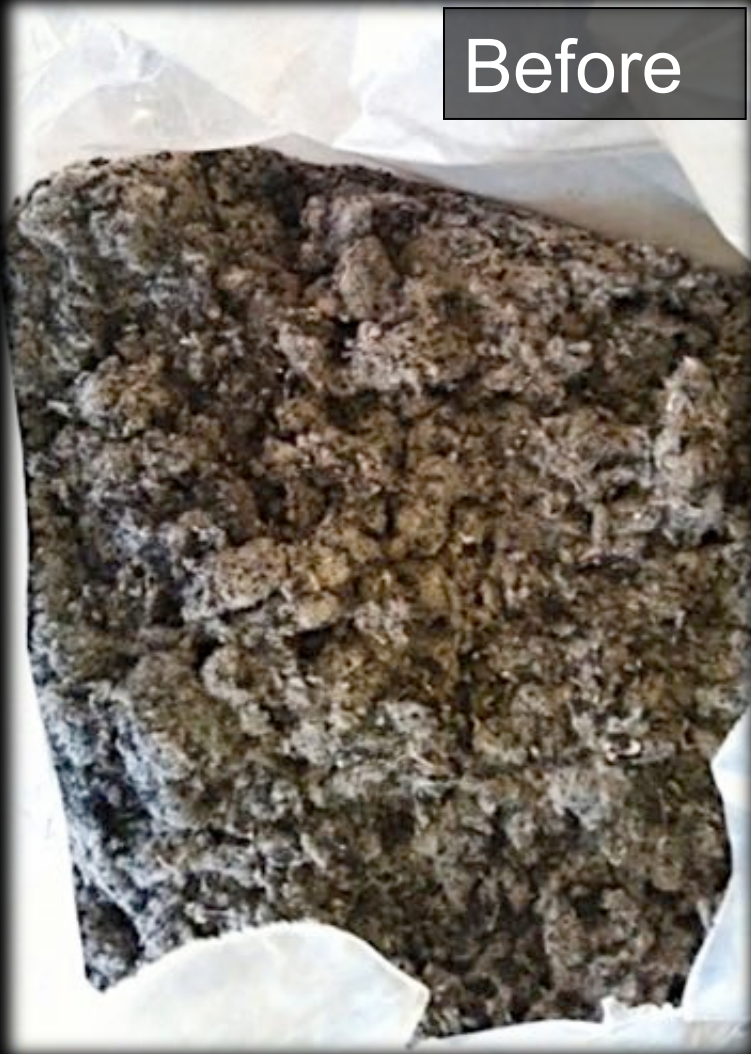
Before

Fibre Processing

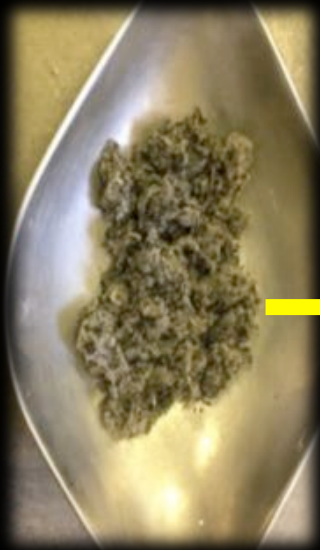
Raw Material

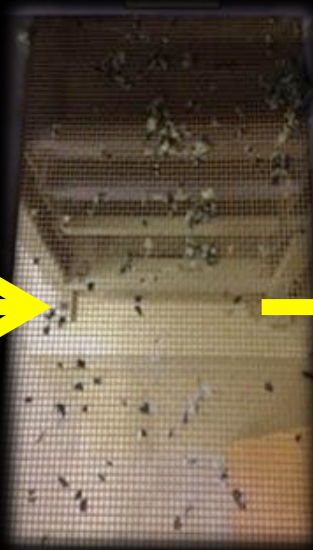
4.75mm Sieve

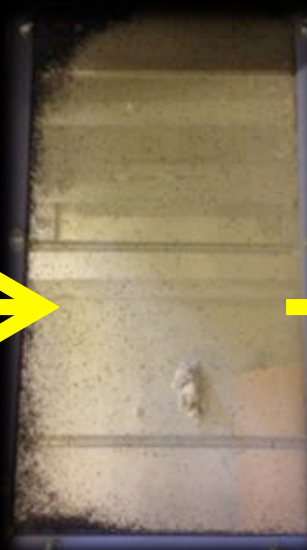
0.042 mm Sieve

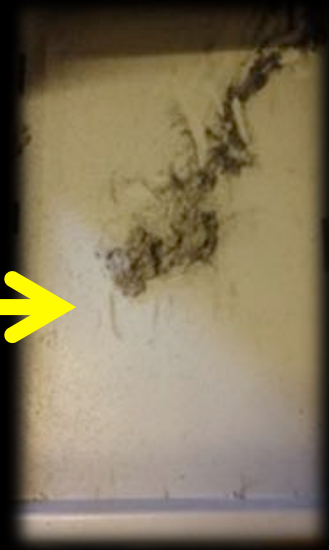
Collection drawer

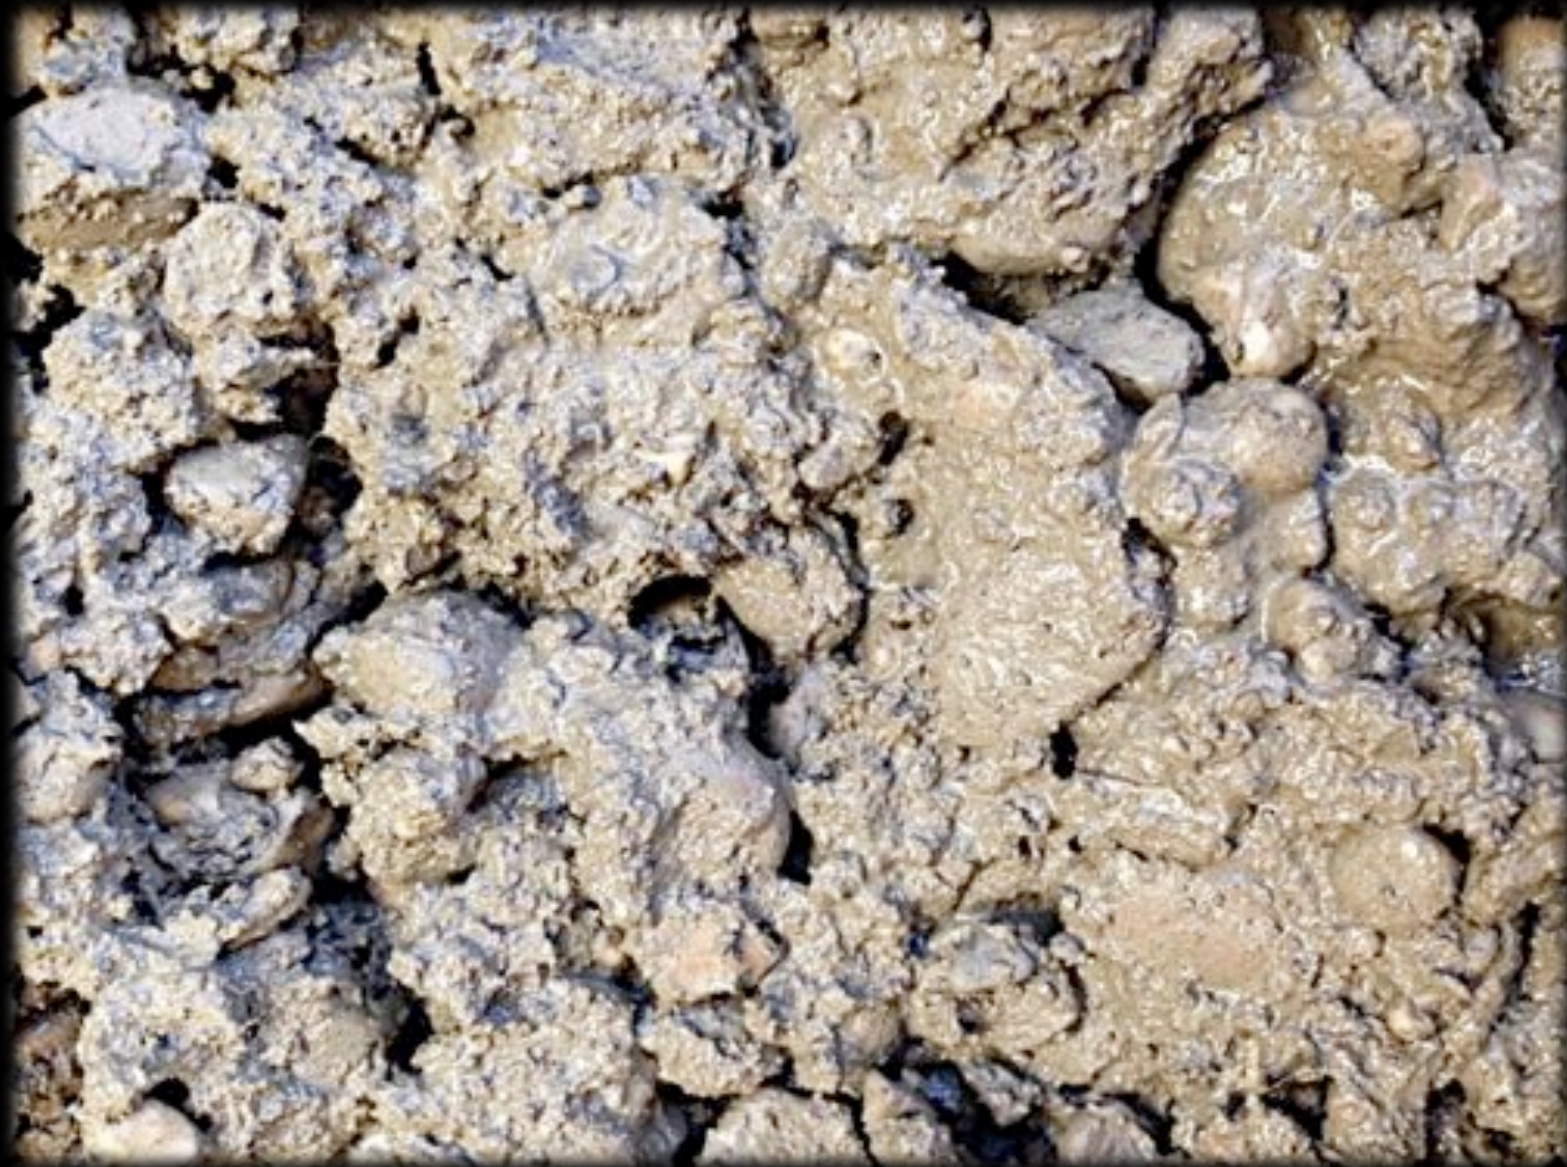
Visible Fibres in Wet Concrete

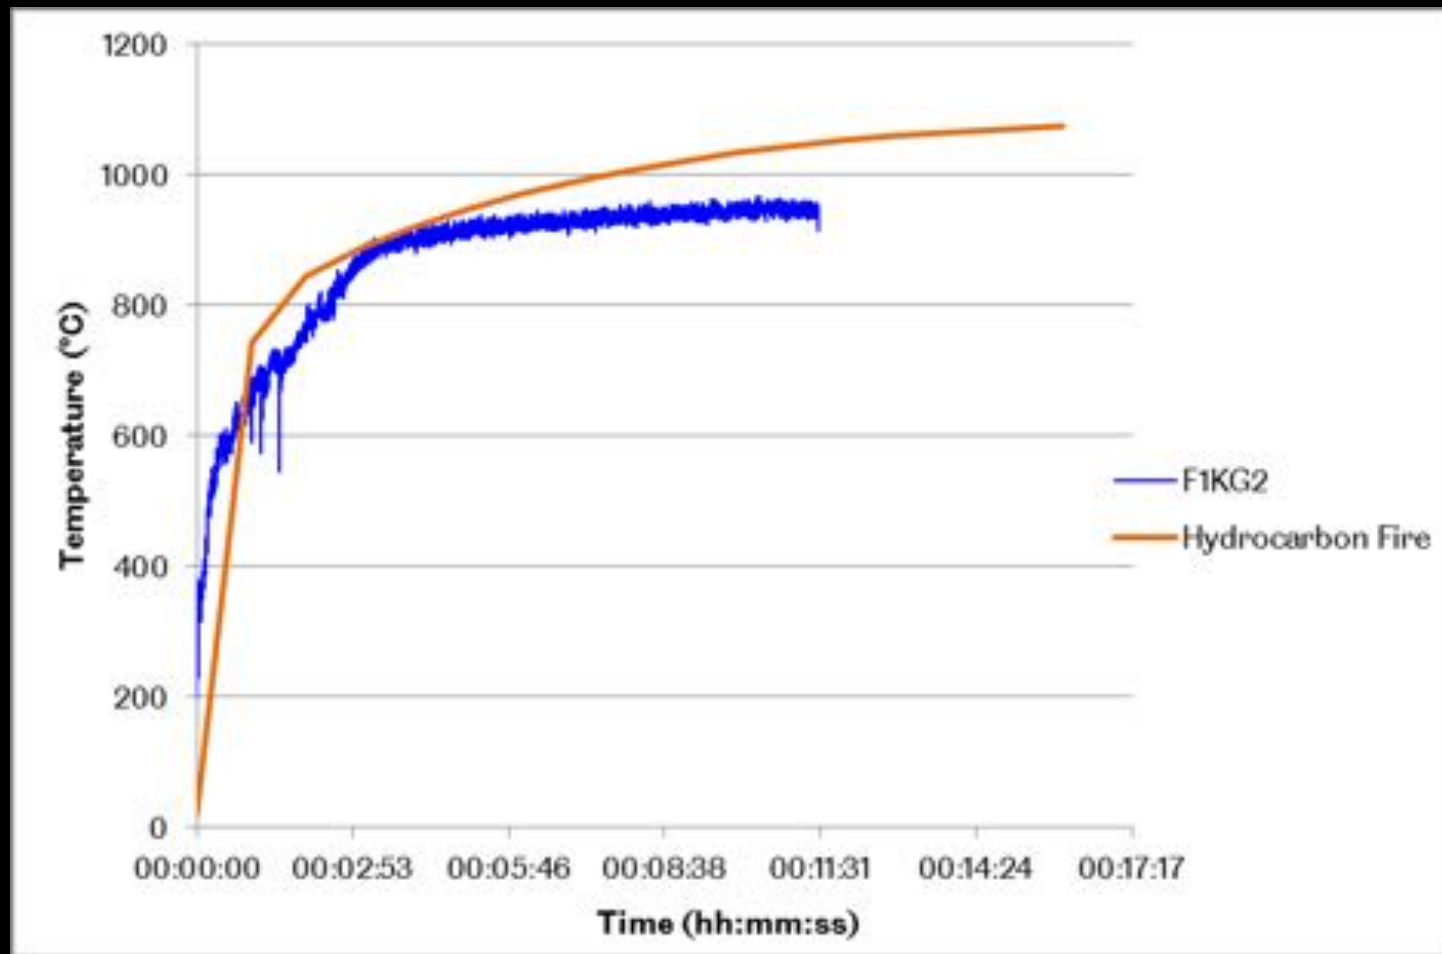
Surface Temperature vs. Hydrocarbon Fire

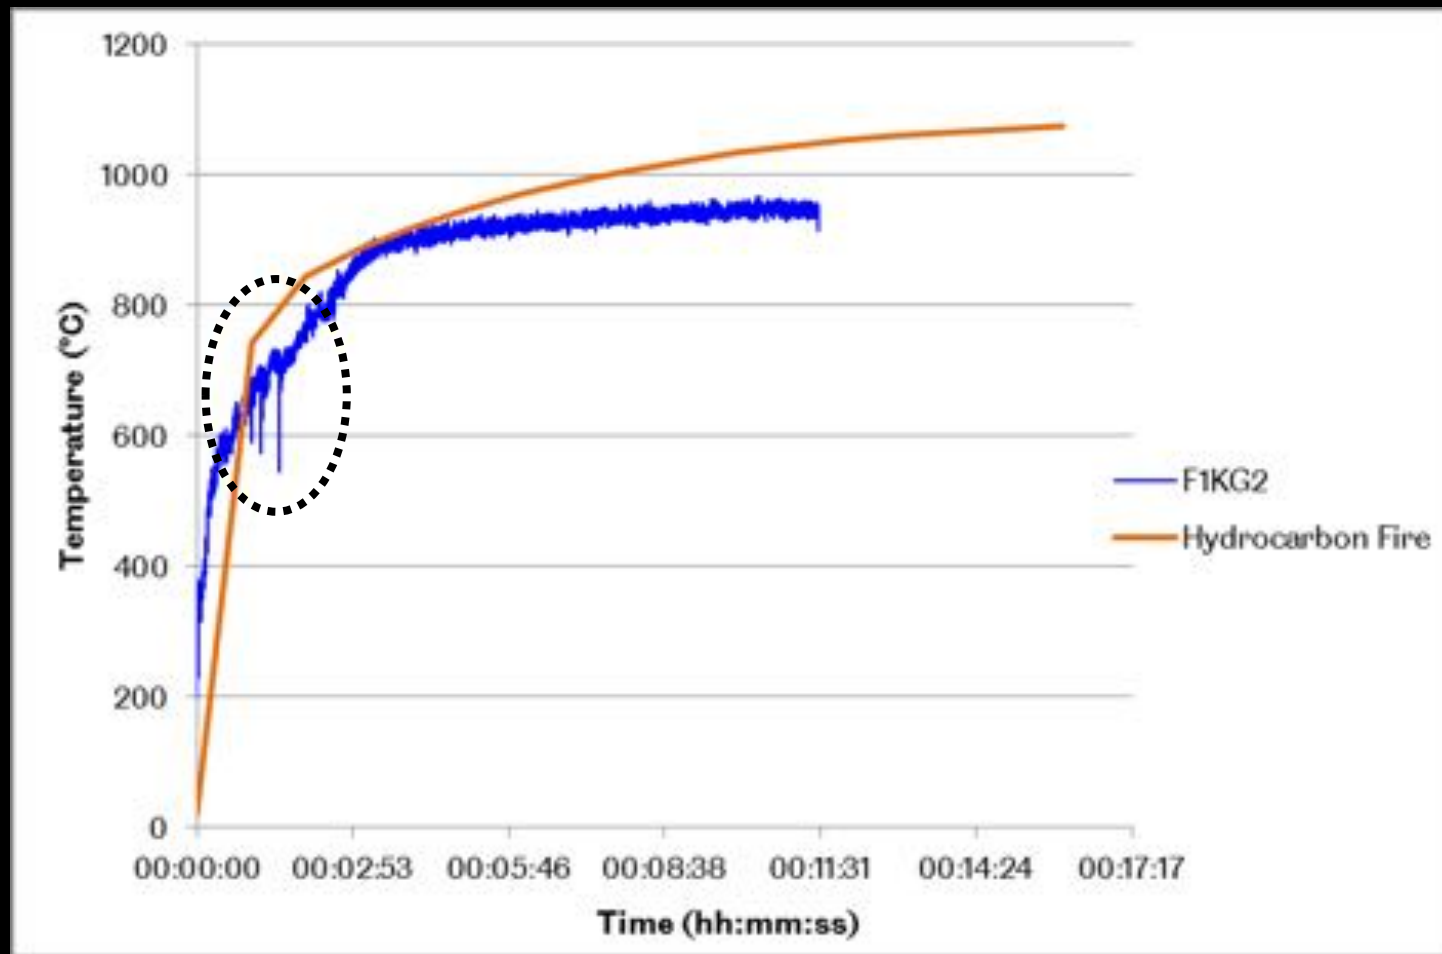
Surface Temperature vs. Hydrocarbon Fire

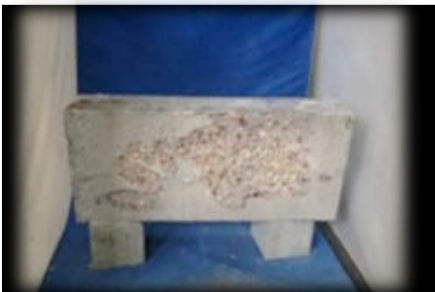
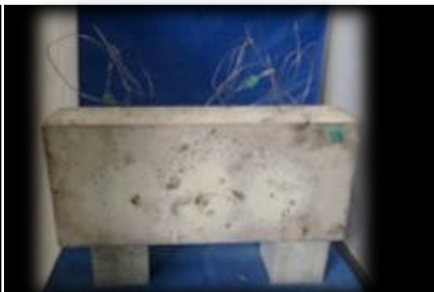
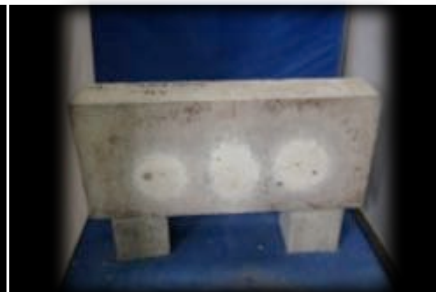
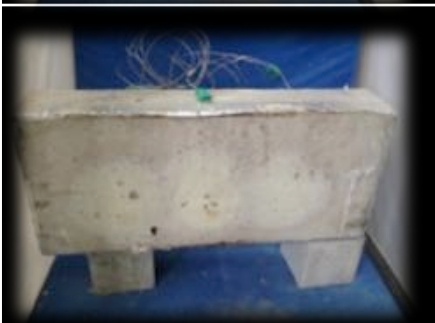
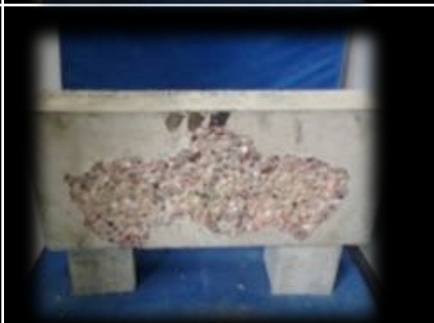
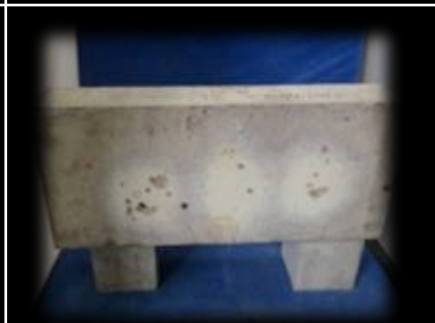
Slab Tests, Series 1 - Aftermath

Plain Concrete	1 kg/m ³ RTPF	2 kg/m ³ RTPF	7 kg/m ³ RTPF

<p>Damaged specimen prior to fire loading</p>

Spall?	Time Taken to Spall (mm:ss)	Cube Strength (MPa)	Moisture Content (%)
P1	Yes	00:30	69	2.2
P2	No	-	70	2.1
P3	Yes	00:24	68	2.2
F1KG1	No	-	65	2.9
F1KG2	Yes	01:00	68	2.9
F1KG3	Yes	00:49	67	3.2
F2KG1	-	-	68	3.2
F2KG2	No	-	67	2.9
F2KG3	No	-	67	3.0
F7KG1	No	-	65	3.4
F7KG2	No	-	65	3.3
F7KG3	No	-	65	3.3

- 3 plain concrete – 2 spalled
- 3 with low RTPF dose (1 kg/m³) - 2 spalled
- **6 with medium & high RTPF doses (2 & 7 kg/m³) - NO spalling**

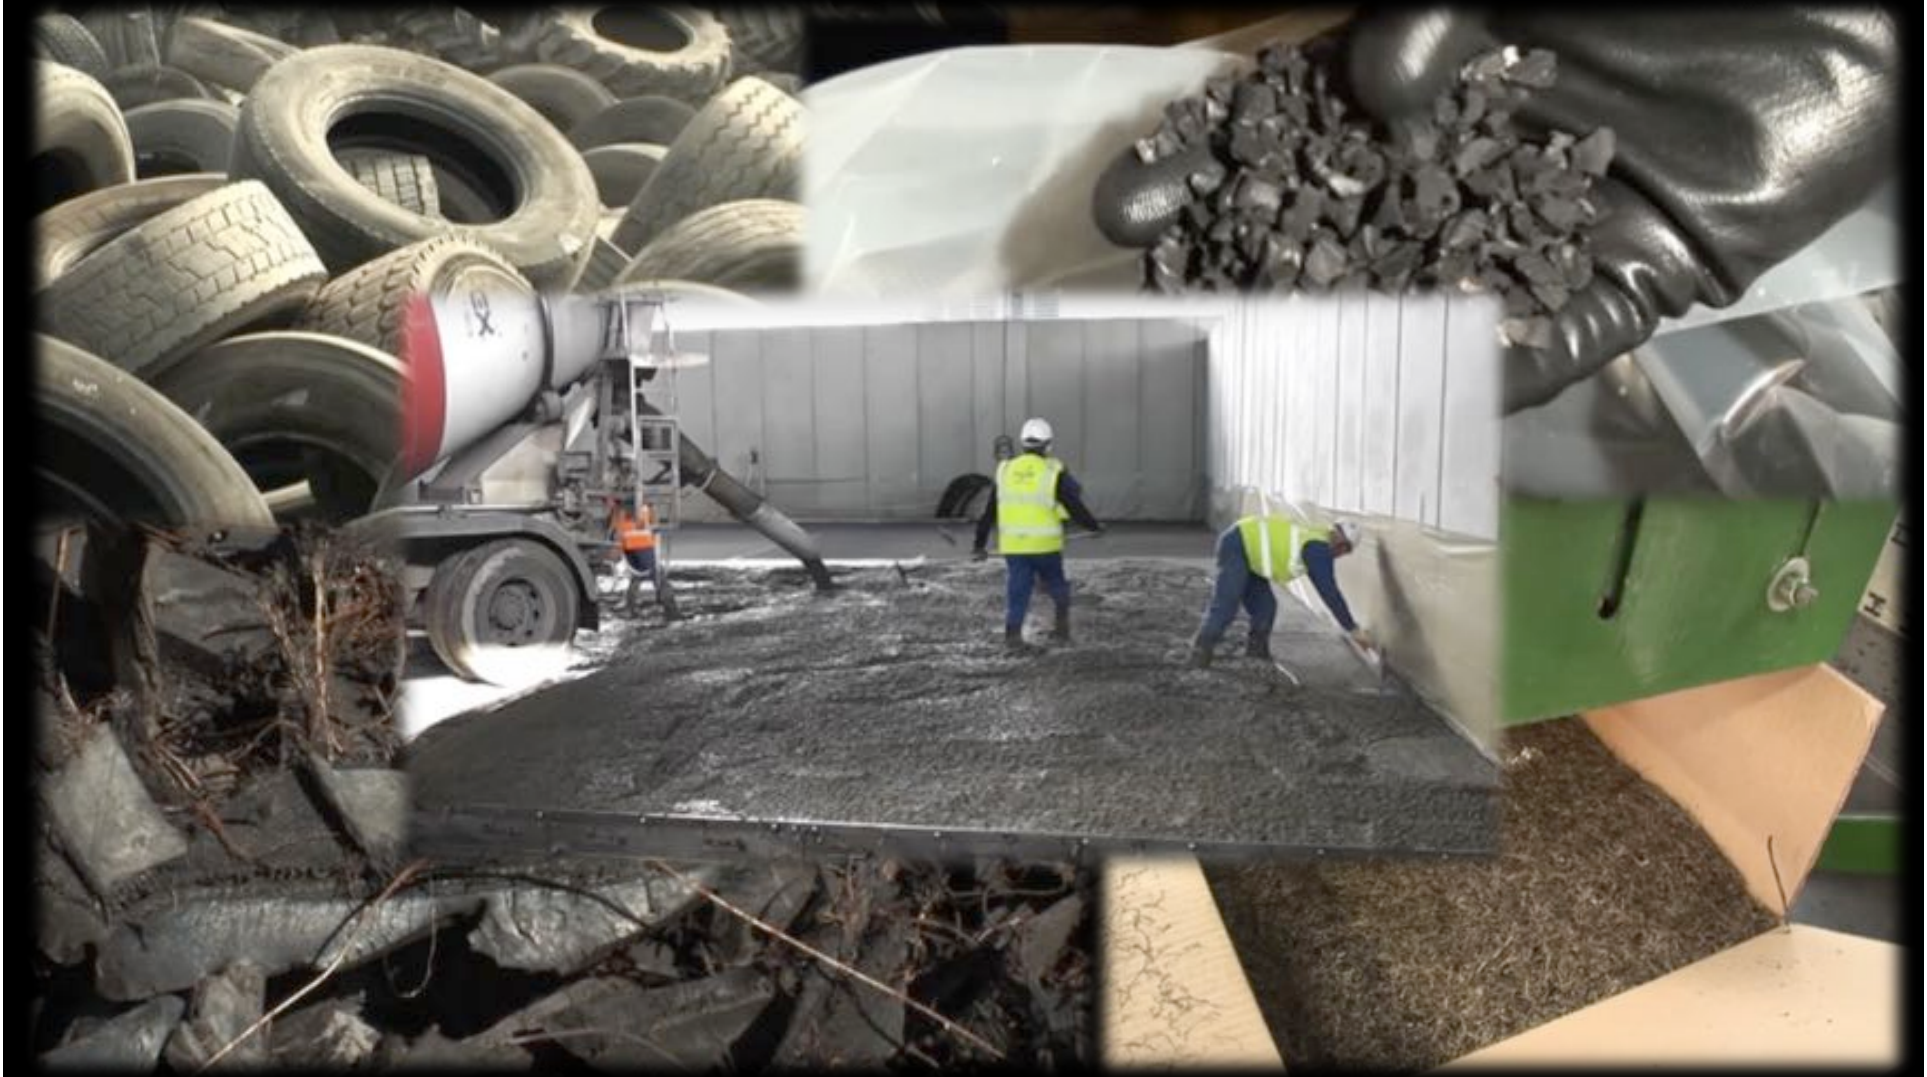
Reused Tyre Steel Fibre (RTSF)
