# Mitigation and Mechanism Study of Fire Spalling of Concrete with Recycled Tyre Fibres

12.05.2023

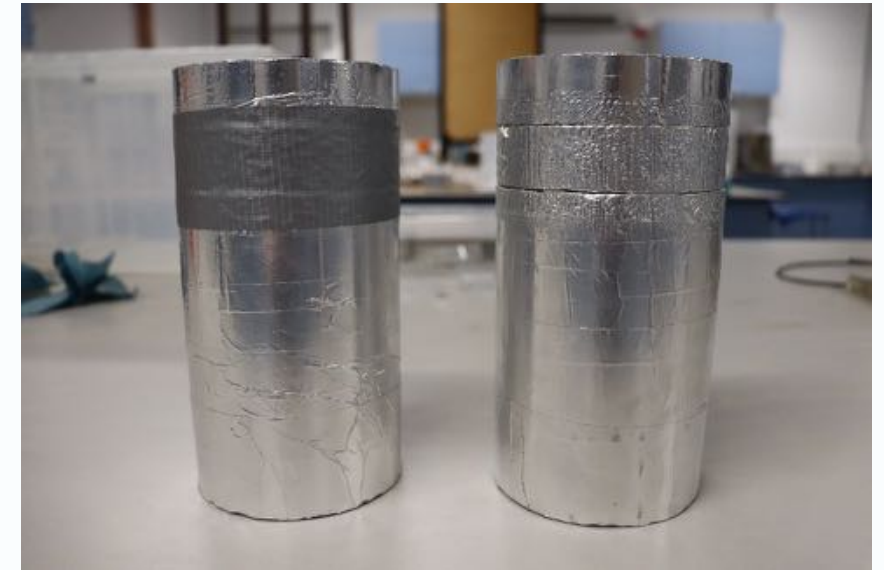
- Cylindrical specimens for moisture content
- Cut at 25 and 50 mm
- Side surface sealed
- Cast, cured and dried in the same condition

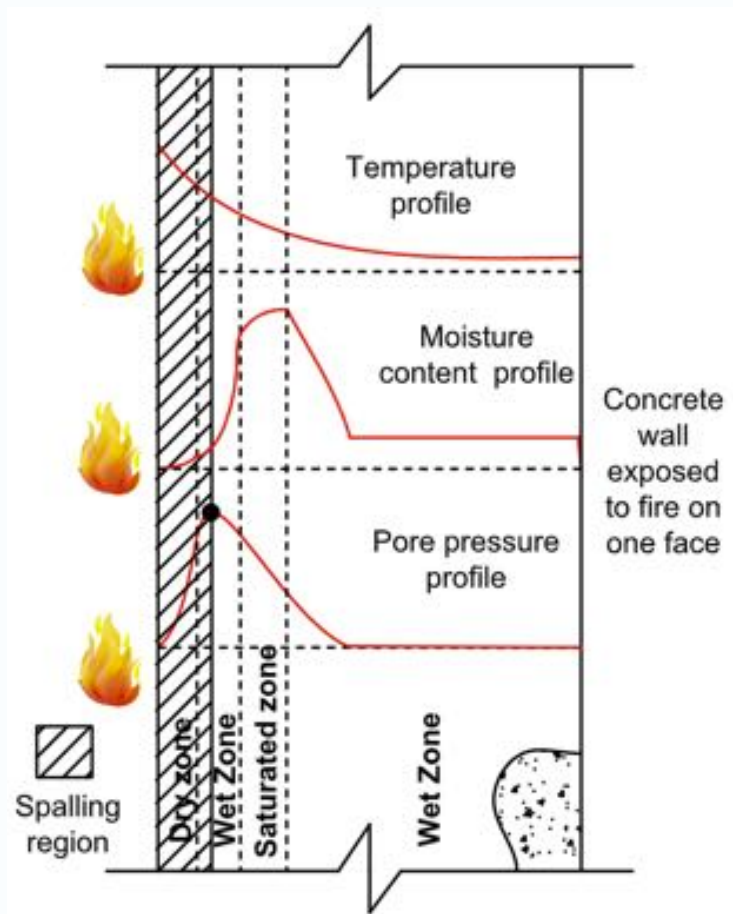
**Thermo-hydral mechanism**

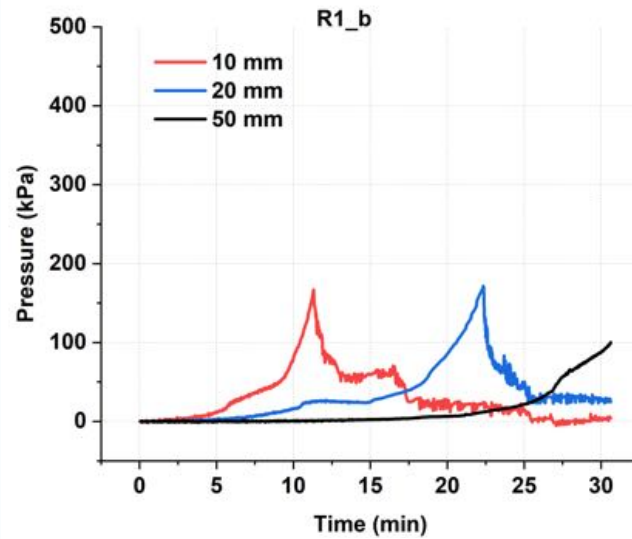
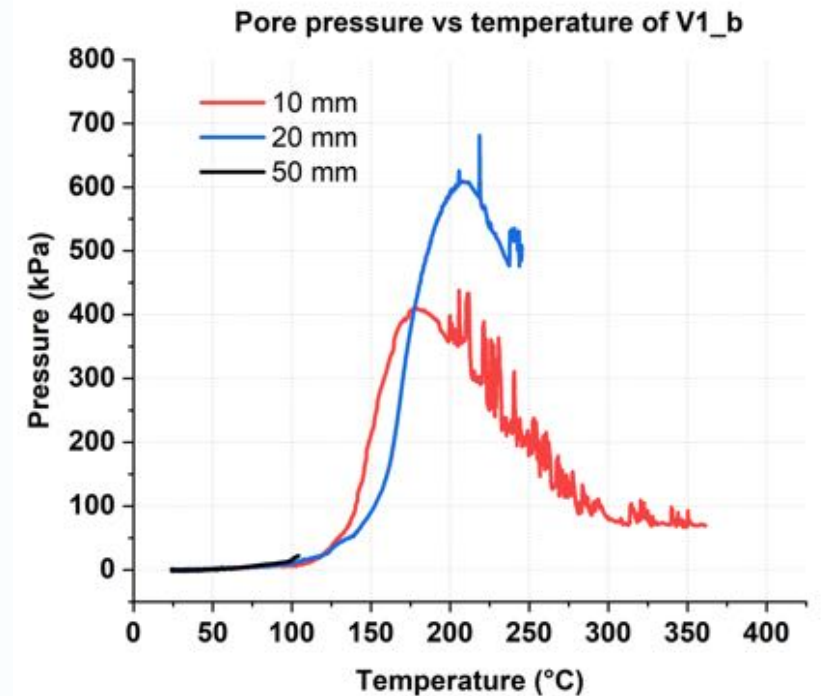
# Pore pressure measurement

- The peak pressure on other specimens is below 0.2 MPa
- The spalling stops the pressure increase further
- Pressure peaked at melting

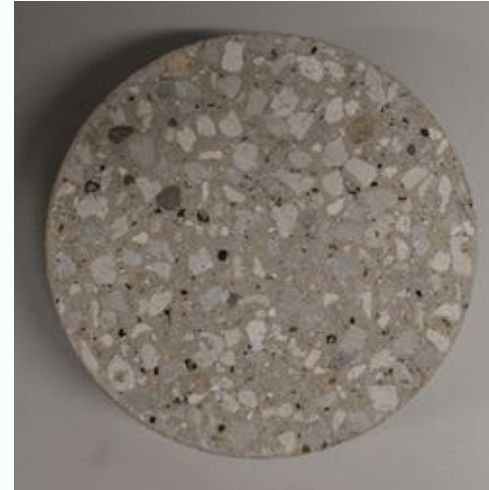
Measured using cylindrical specimens with grinded surface to remove the cement layer.

The post heating permeability was measured when concrete cooled naturally.

Melting of virgin PP fibre increase the permeability, un-melted RTPF controlled the thermal crack.

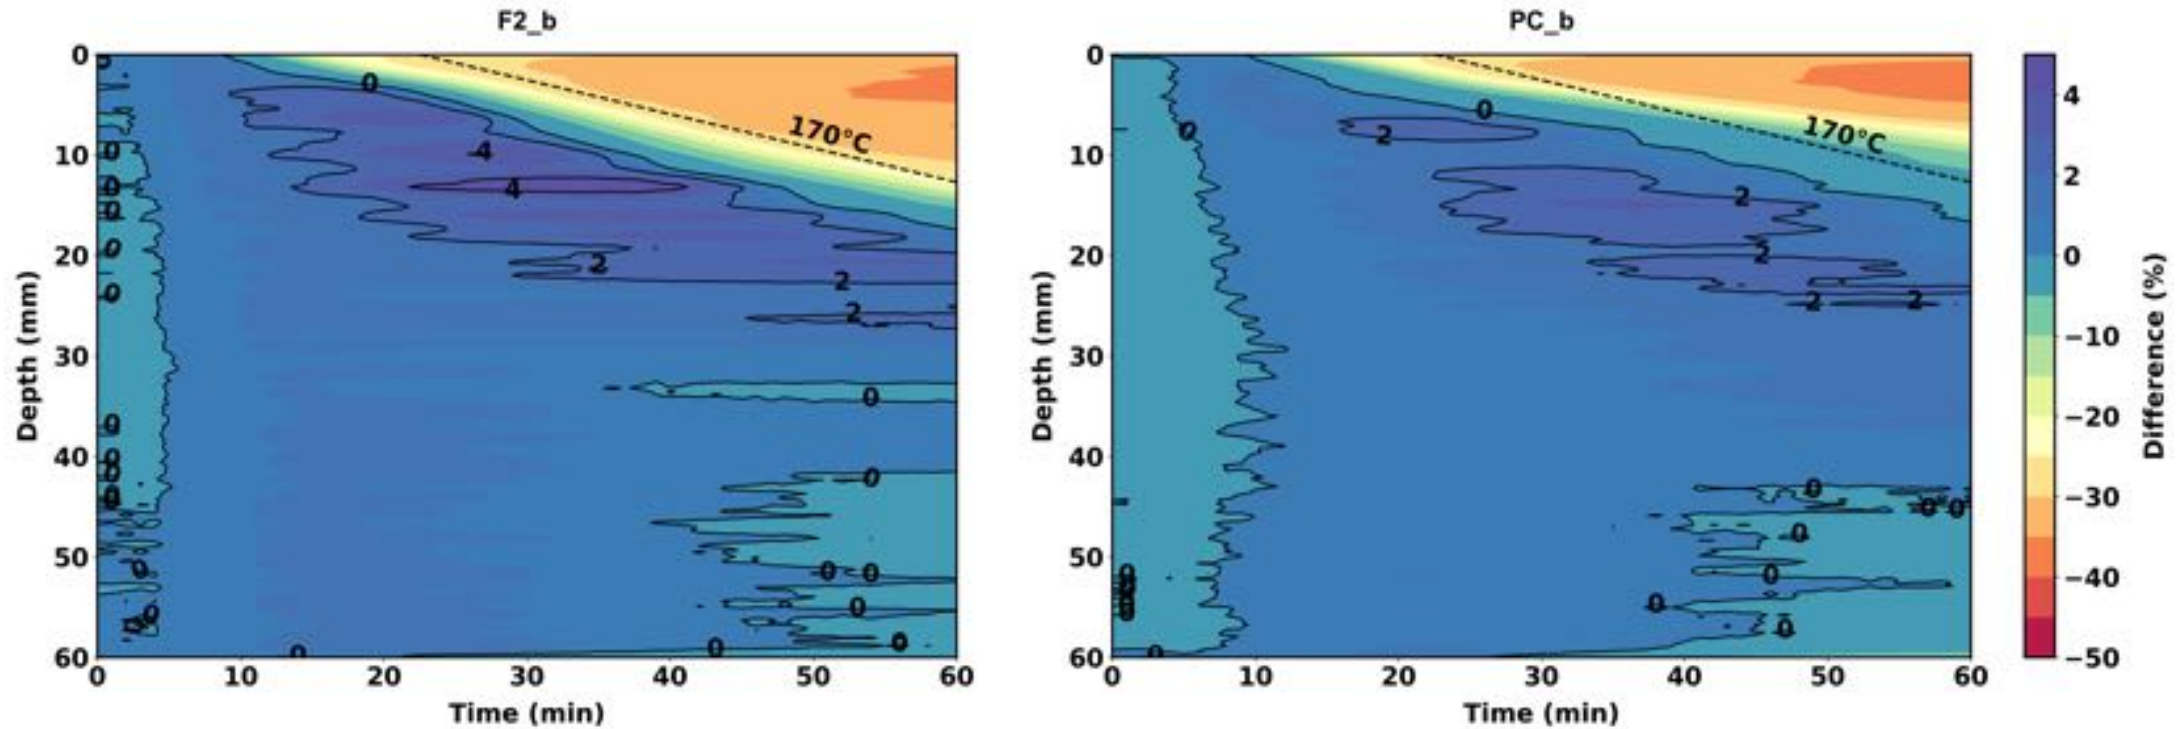
Average grey value map indicating the moisture change in heated concrete.

Zero means no difference in moisture compared to the initial state.

Positive value means water accumulation, negative value means water drying

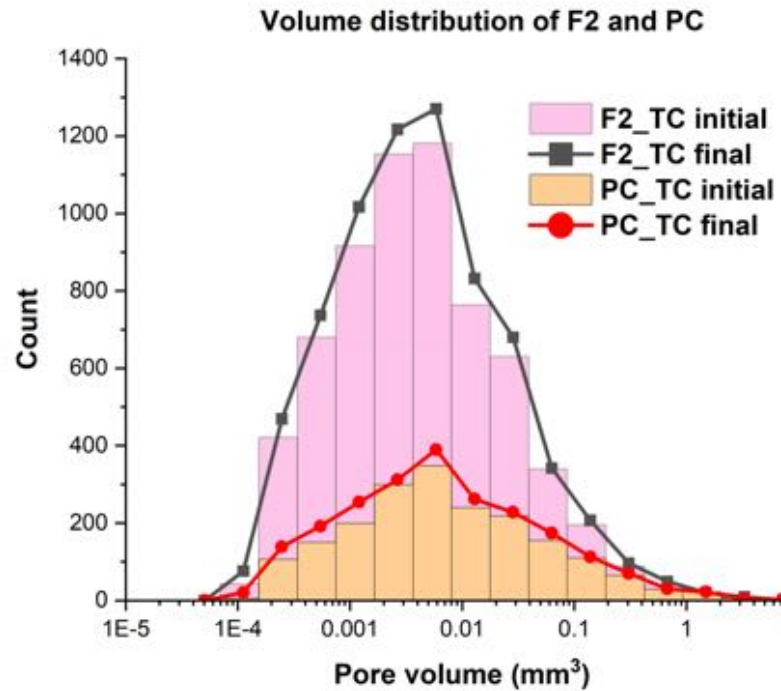
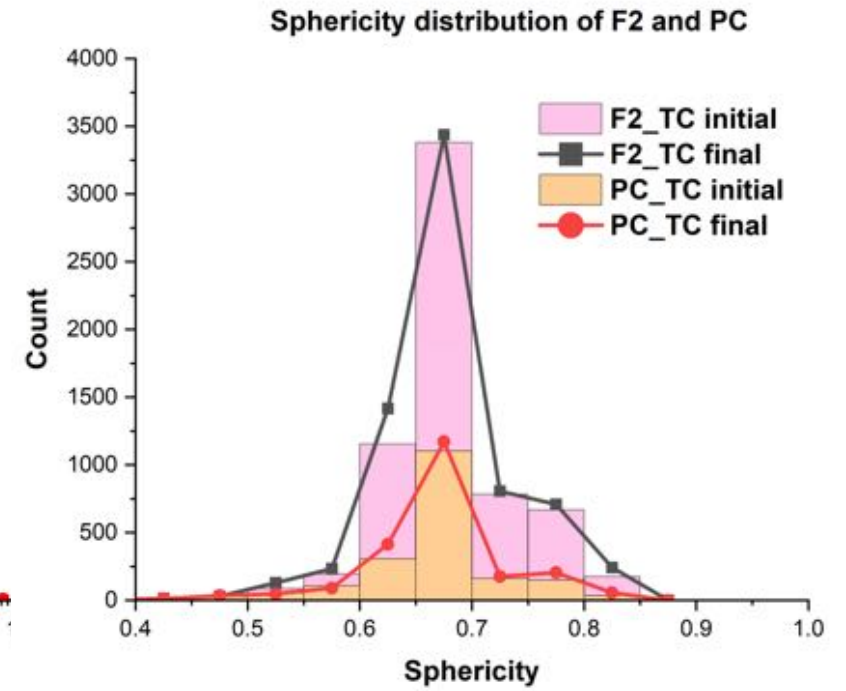
# Pore structure of heated concrete

Addition of polymer fibre can increase the intrinsic porosity (Macropores)  
The heating process did not significantly increase the macro porosity  
No obvious crack opening was observed from the sphericity distribution
