FIRE DYNAMICS IN INFORMAL SETTLEMENTS

A. CICIONE (PhD Cand.) & Dr. R.S. WALLS

OVERVIEW OF PRESENTATION

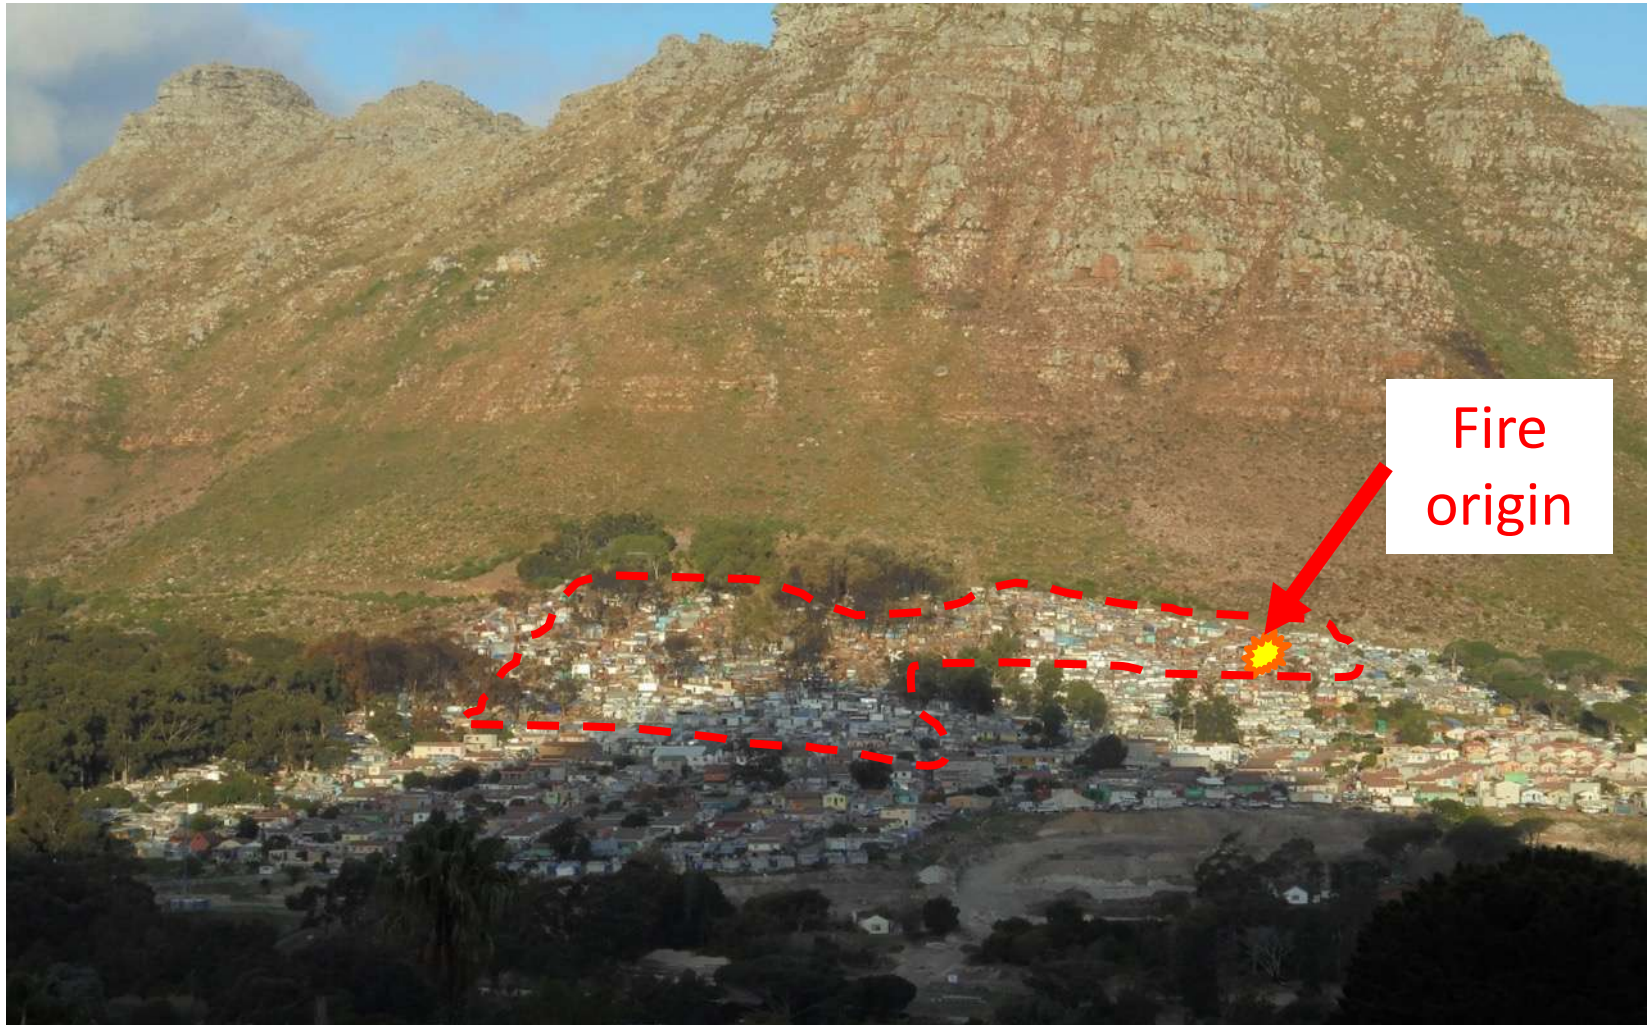
IMIZAMO YETHU FIRE – 11 MARCH 2017

Fires starts around 23:00-00:00

00:26 – First emergency call
00:28 – Hout Bay Fire Station team dispatched (approx. 1km away)

±00:40
Hose cut by resident.
Fire quickly becomes out of control. Water rapidly lost.

**After 01:00
Support arrives from
other departments.
Wind direction starts
changing.**

**00:40 onwards
New line run and
firefighting continues.
Fire spreads. Second fire
station team involved.**

03:00-07:00
Evacuating residents block routes as they move their positions and cars park in the way of firefighting vehicles.

**Fire moves downslope,
propelled by wind. Terrain
makes access difficult**

**Fire line reaches trees which
catch fire. Fire spreads
rapidly and becomes
extremely intense.**

09:00-13:00
Aerial operations with
water bombing.

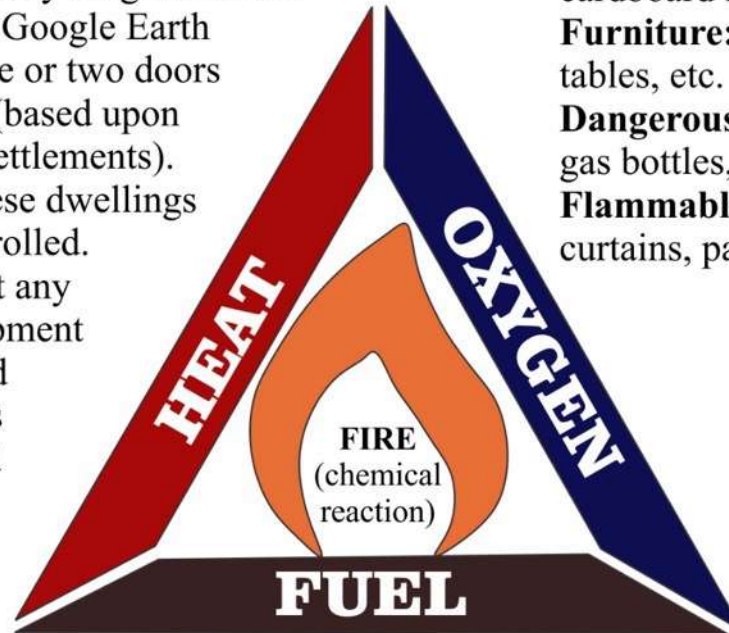
Ventilation conditions in ISDs

The floor area of ISDs typically range between 5m² and 30m² (verified with Google Earth Data) and typically have one or two doors and windows, respectively (based upon authors' visits to informal settlements). The above indicates that these dwellings are usually ventilation controlled. However, this can change at any stage during a fire's development as a result badly constructed walls dislodging walls. This phenomenon was witnessed during the full-scale tests.

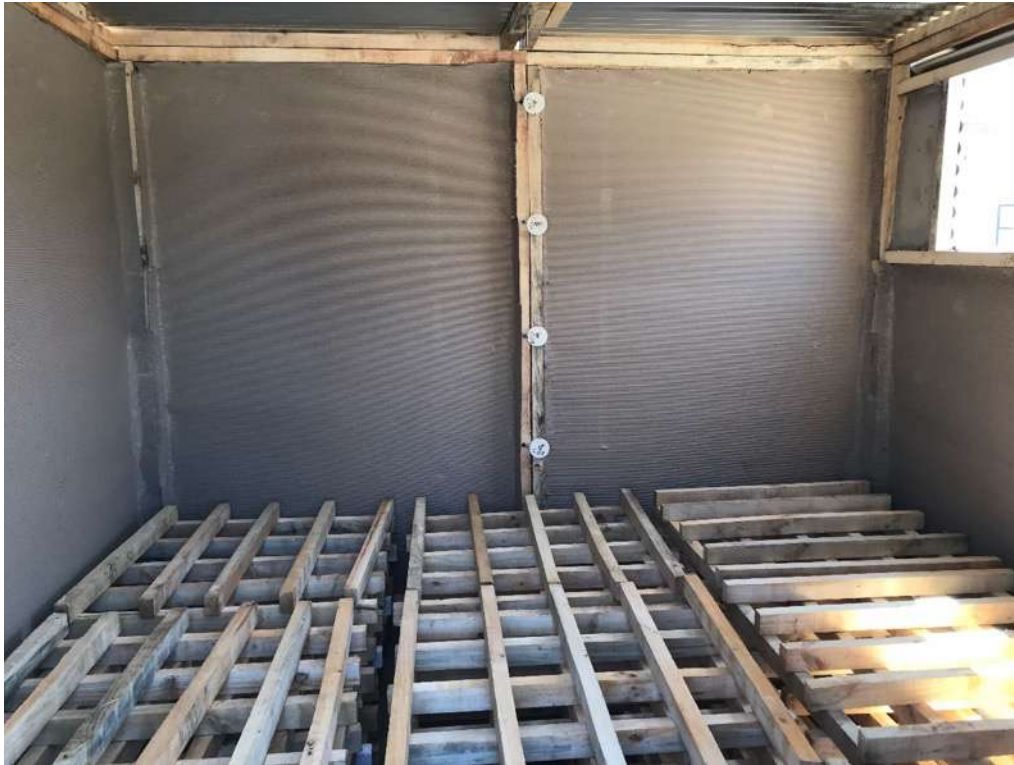
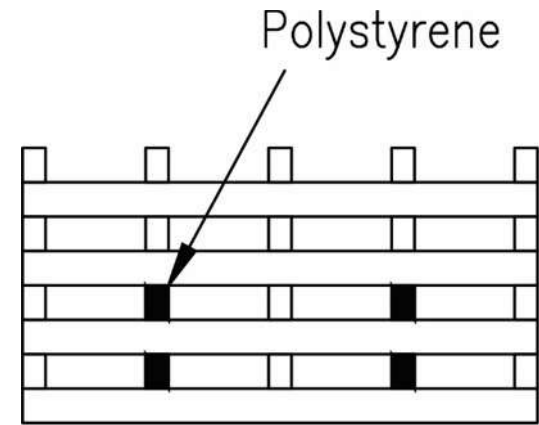
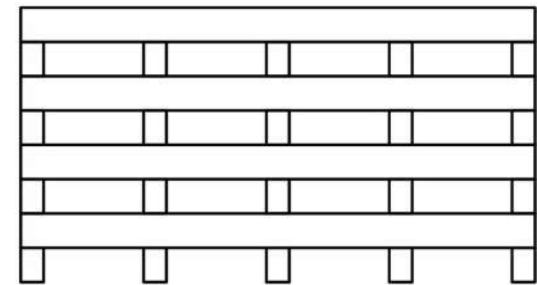
STANDARDIZED ISD

- **FUEL LOAD: 45 kg/m² according to EU Code**

Front View

Side View

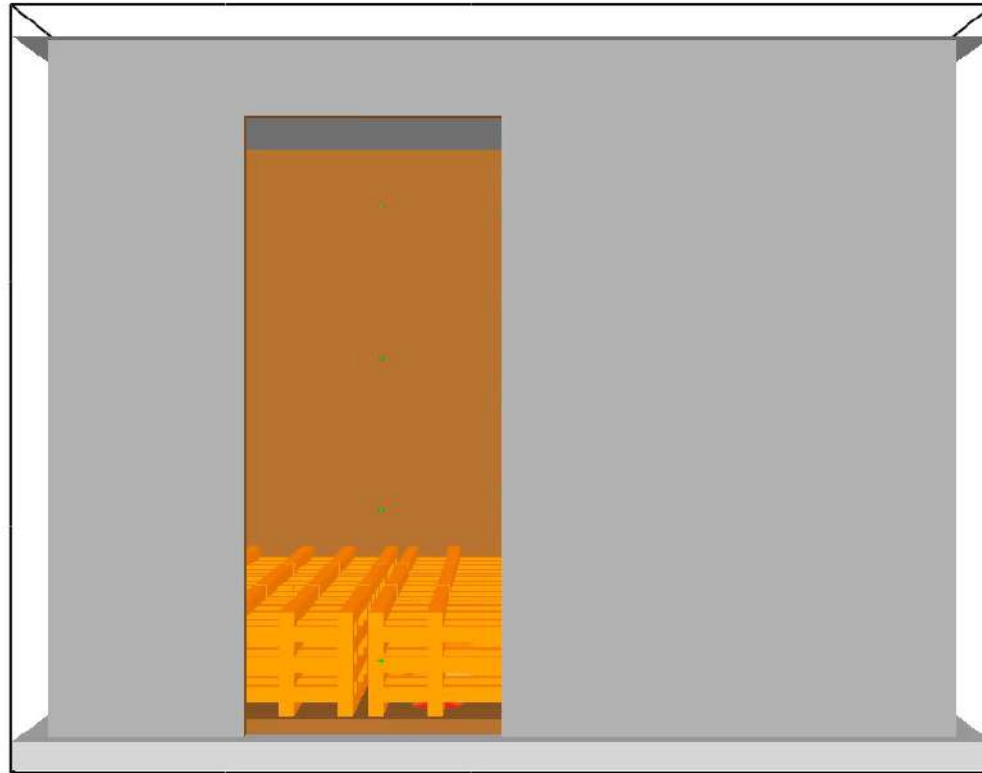
PRELIMINARY CFD MODEL BEHAVIOUR

Time: 240.0

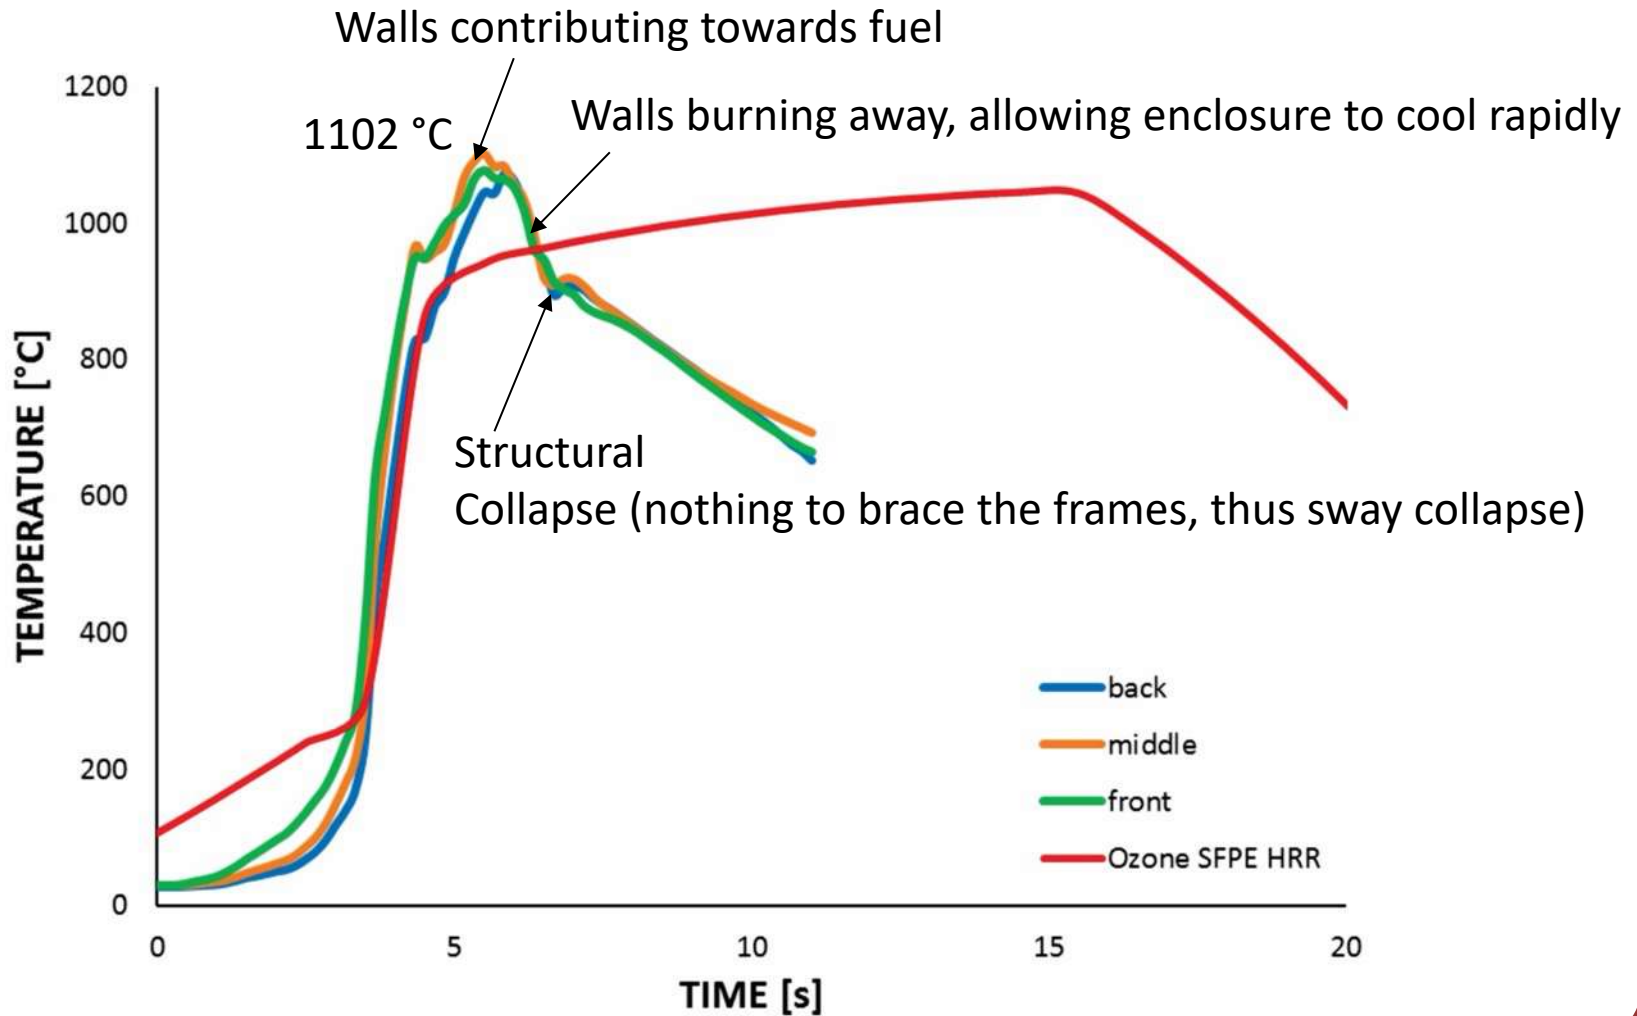
TWO ZONE MODEL REPRESENTATION OF RESULTS

Collapse

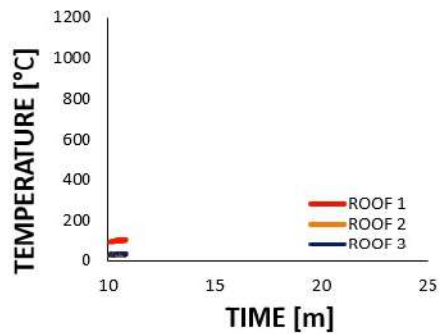
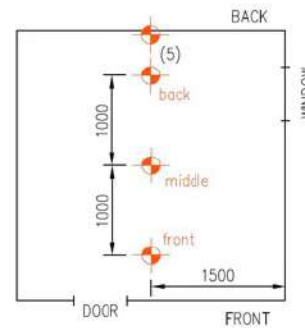
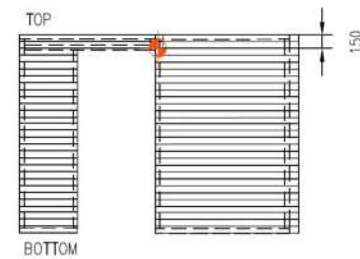
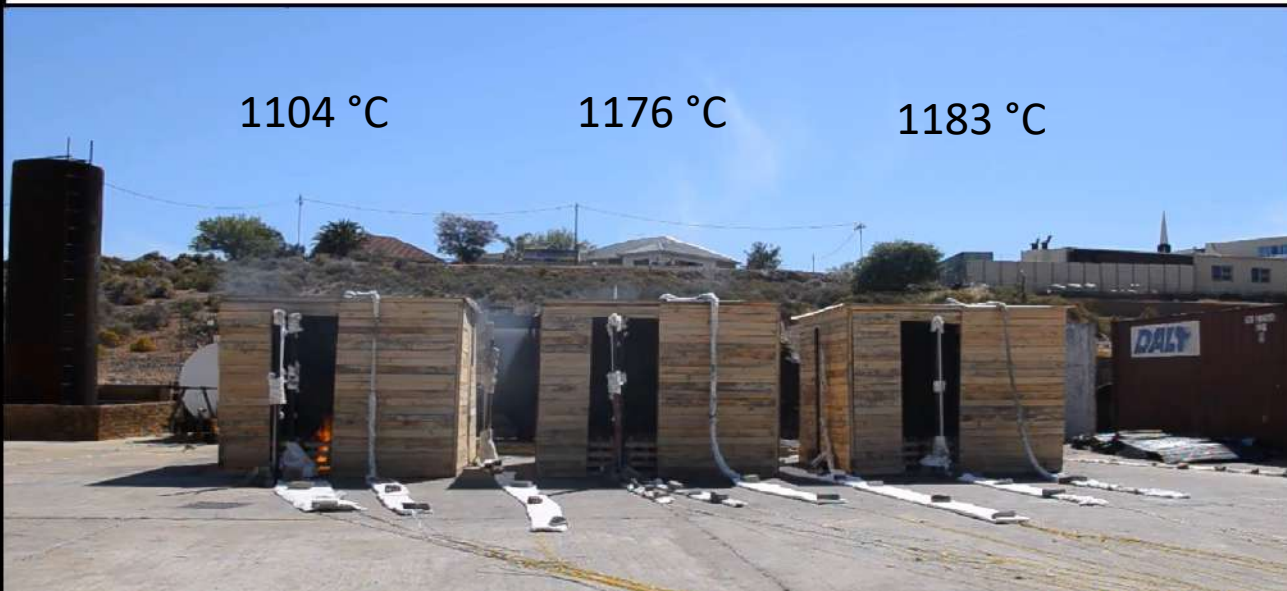
RESULTS: MULTI-ISD ROOF TEMPERATURES

1104 °C

1176 °C

1183 °C

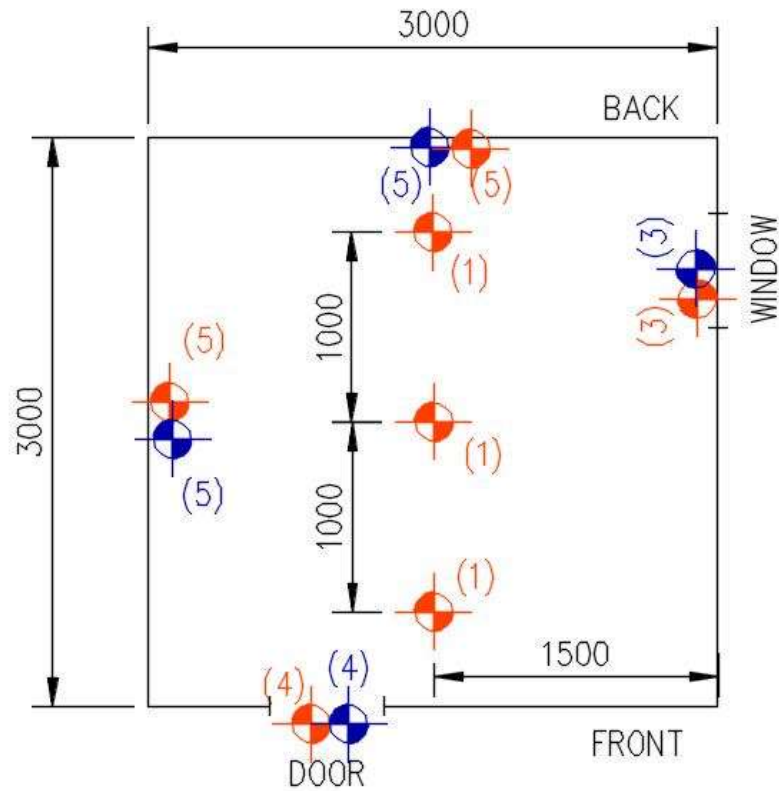
TEST SETUP: SINGLE STEEL ISD

EXPERIMENTAL EQUIPMENT KEY

THERMOCOUPLES

THIN-SKINNED CALORIMETERS

SINGLE SHACK TEST

PLAN VIEW

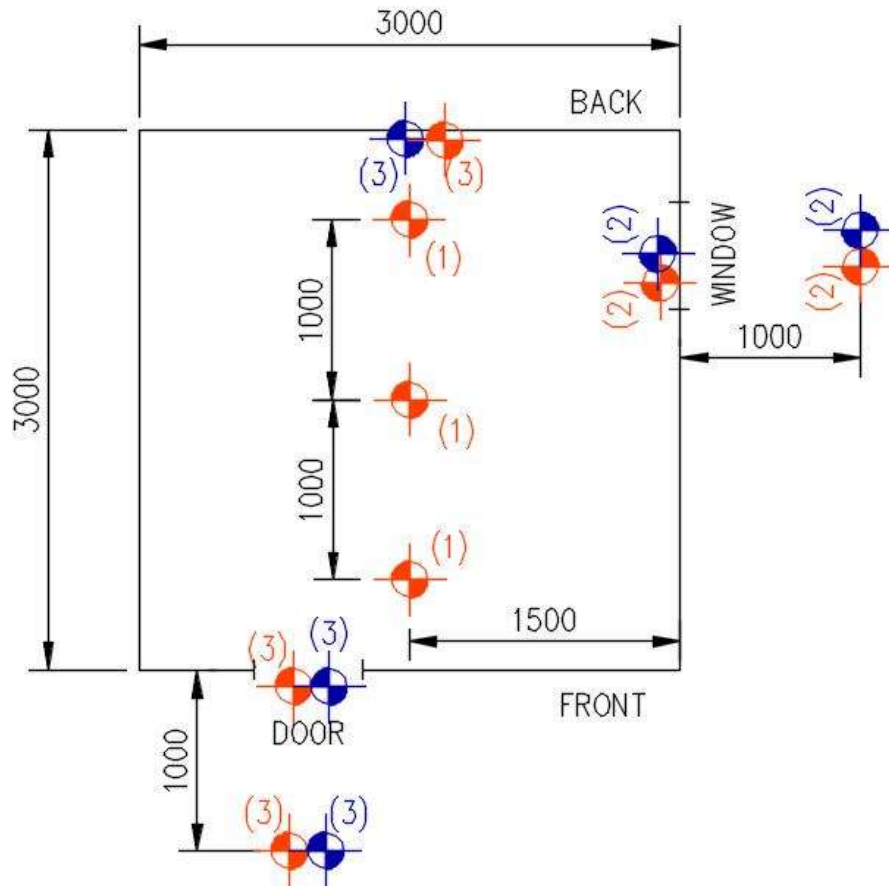
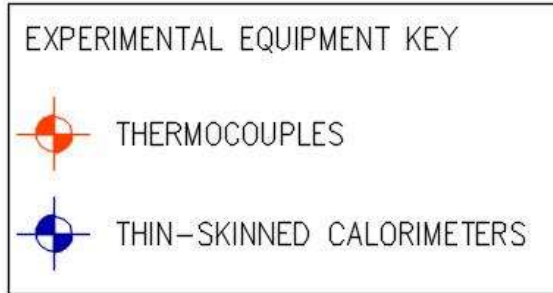
TEST SETUP: SINGLE TIMBER ISD

SINGLE SHACK TEST

PLAN VIEW
