# Post-fire damage quantification of concrete cut-and-cover tunnels

Thomas Thienpont  
Ghent University  
26.09.2025

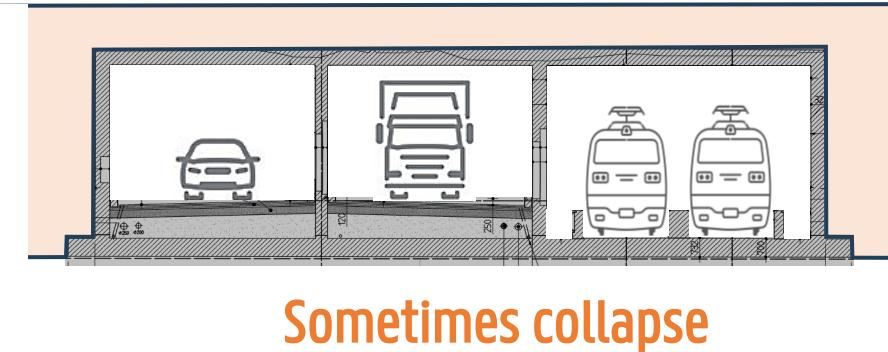
🔥 RWS120 – spalling 5mm/min (up to rebar)
