# Damage assessment, residual cyclic behaviour and repair of fire-exposed reinforced concrete columns

*Preliminary experimental results from fire resistance & residual cyclic loading tests*

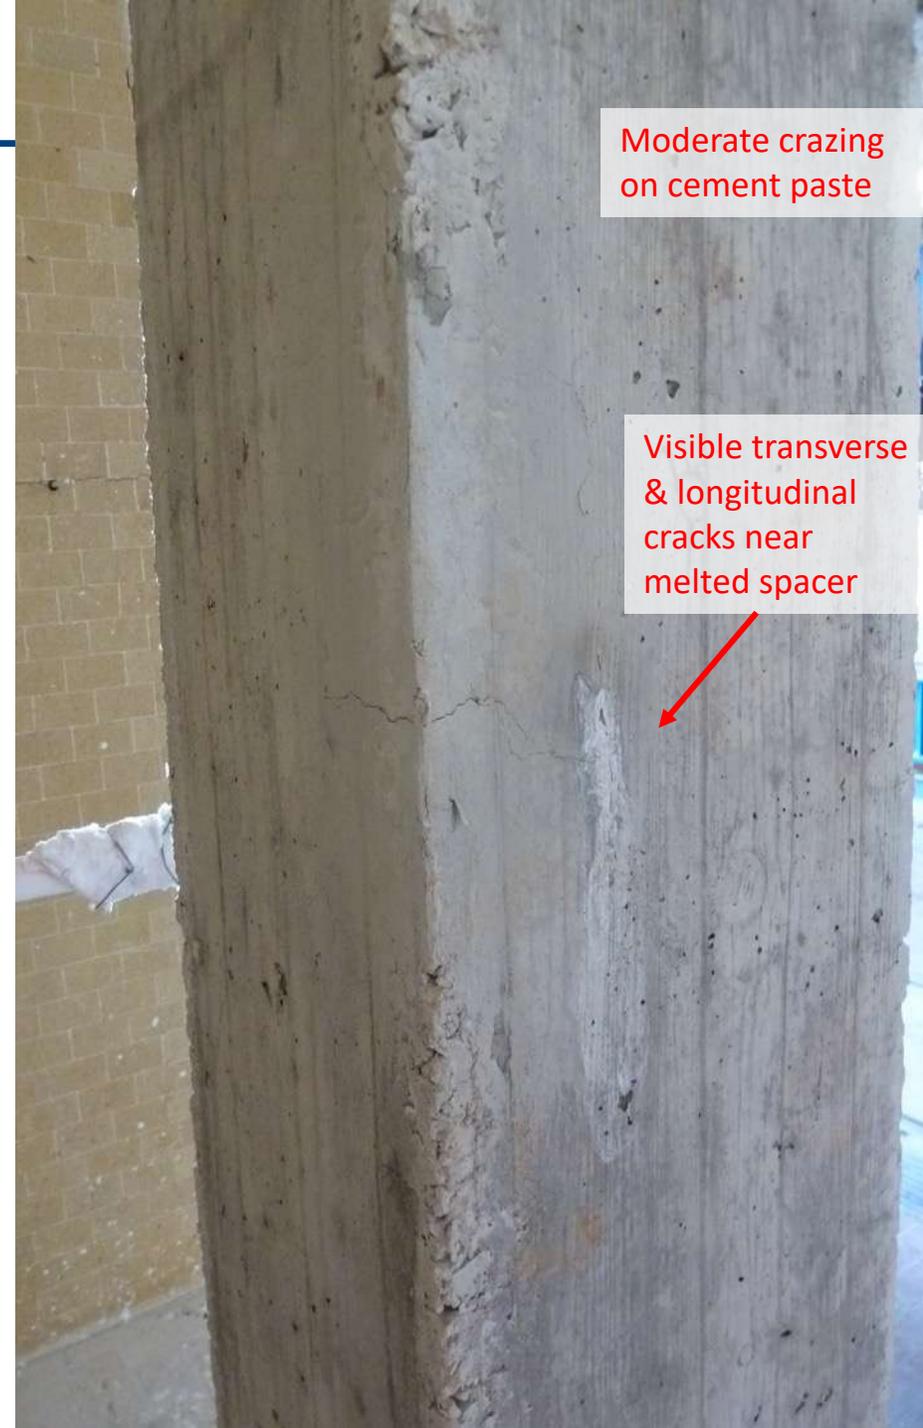
Moderate crazing on cement paste

Visible transverse & longitudinal cracks near melted spacer

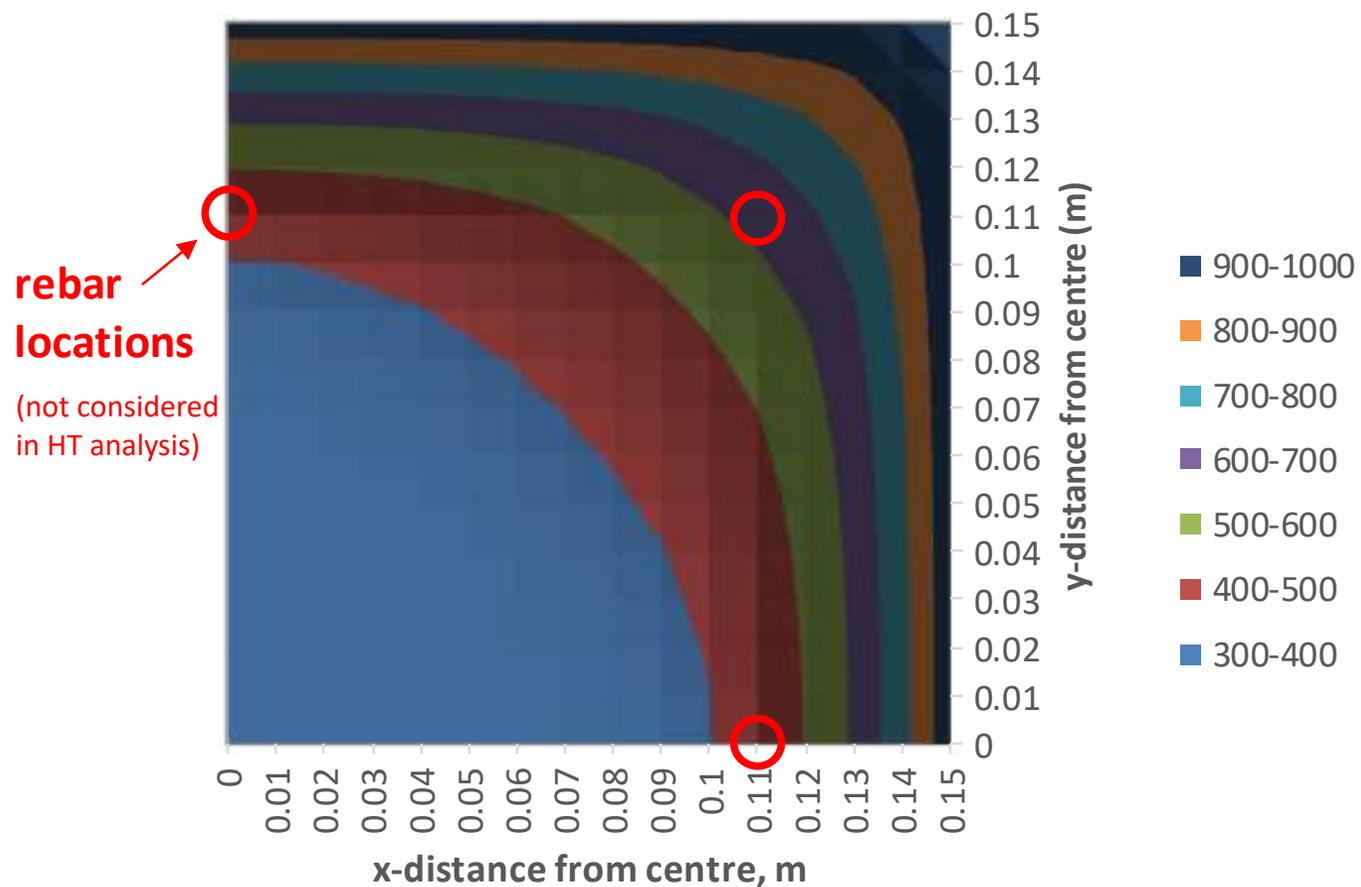
Max temperature @Section A-A (¼-model FEM results)

*“Concrete not structurally useful after heating in temperatures in excess of 550°C-600°C”*

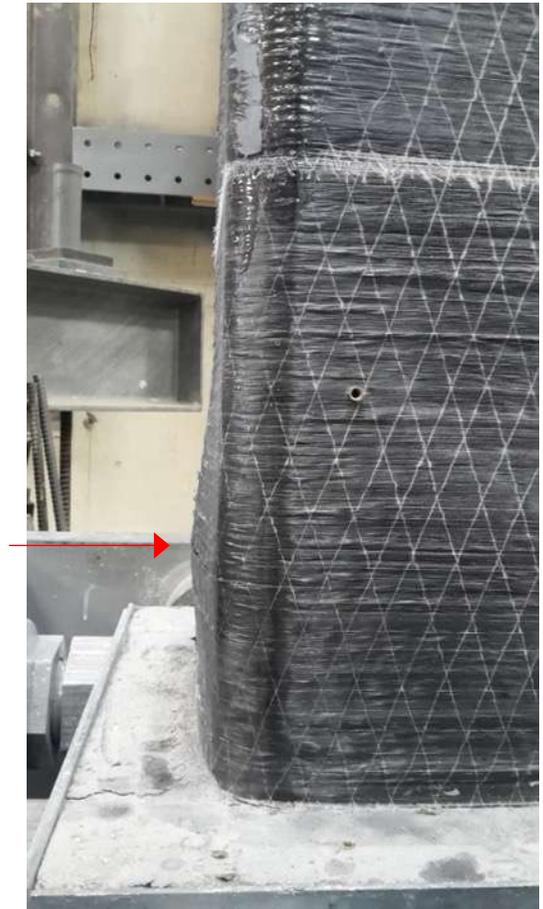
Flexural cracks between transverse unidirectional carbon fibres

Bulging due to middle rebar buckling

\*Test stopped before the wrap reached its ultimate tensile (hoop) strain
