# Laterally loaded light timber frame fire experiments

Daniel Jessop (Cosgroves Ltd, Christchurch)

Colleen Wade (BRANZ), Hans Gerlich (Winstone Wallboards),  
Michael Spearpoint and Tony Abu (University of Canterbury)

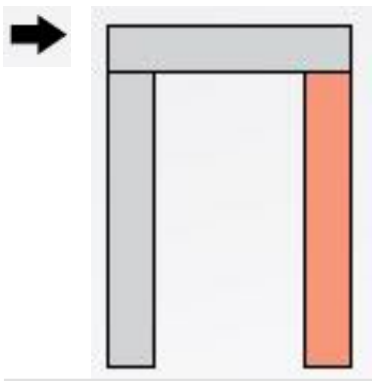
Before Fire	During Fire	After Fire
<ul style="list-style-type: none"><li>• Stability achieved by support from walls and roof structure</li><li>• Normal design loads (wind, earthquake) are greater than 0.5 kPa after-fire load</li></ul>

<p>The diagram shows a cross-section of a wall (orange) supported by a non-fire-rated timber frame (grey). A black arrow points from the left towards the wall, indicating a lateral load.</p>	<ul style="list-style-type: none"><li>• Wall &amp; ceiling plasterboard linings fail</li><li>• Timber framing exposed directly to fire, charring occurs, reducing strength</li></ul>

Wall supported by non fire rated structure	Wall supported by degraded structure	One wall only remaining

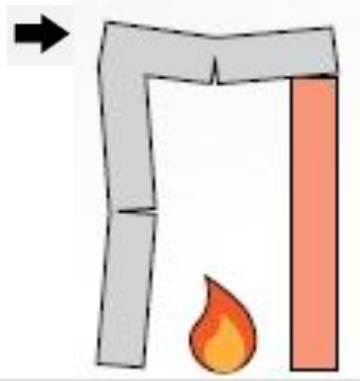
<p>The diagram shows the same wall and timber frame during a fire. The plasterboard linings are shown failing and falling away. The timber frame is exposed to a fire (flame) at the base, and the top of the frame is shown charring and sagging. A black arrow points from the left towards the wall.</p>	<ul style="list-style-type: none"><li>• Only fire-rated elements remain</li><li>• Lateral 0.5 kPa load applied to external wall. Assume that wall linings are intact.</li></ul>

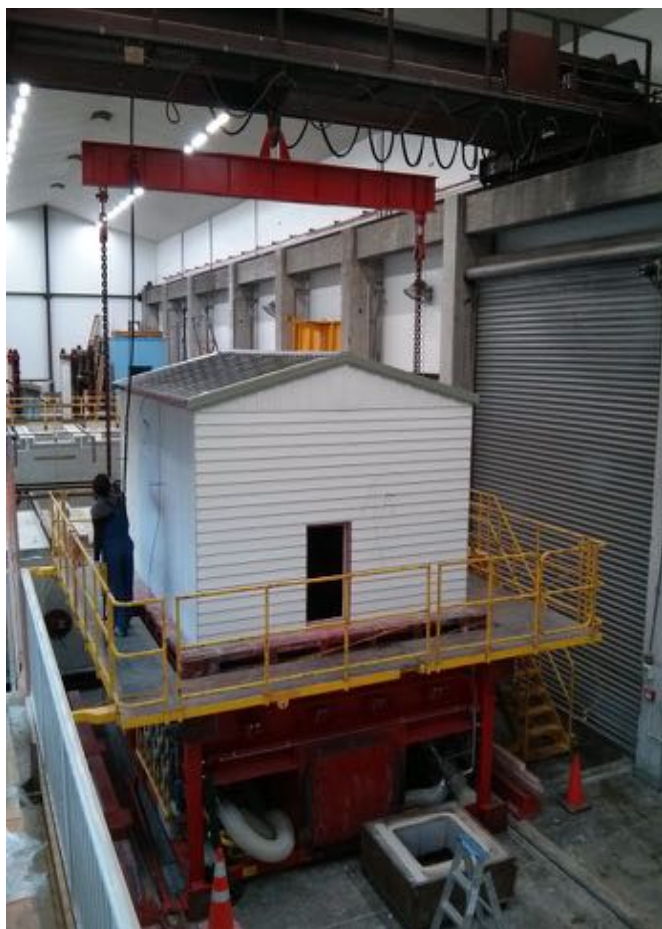
Set-up

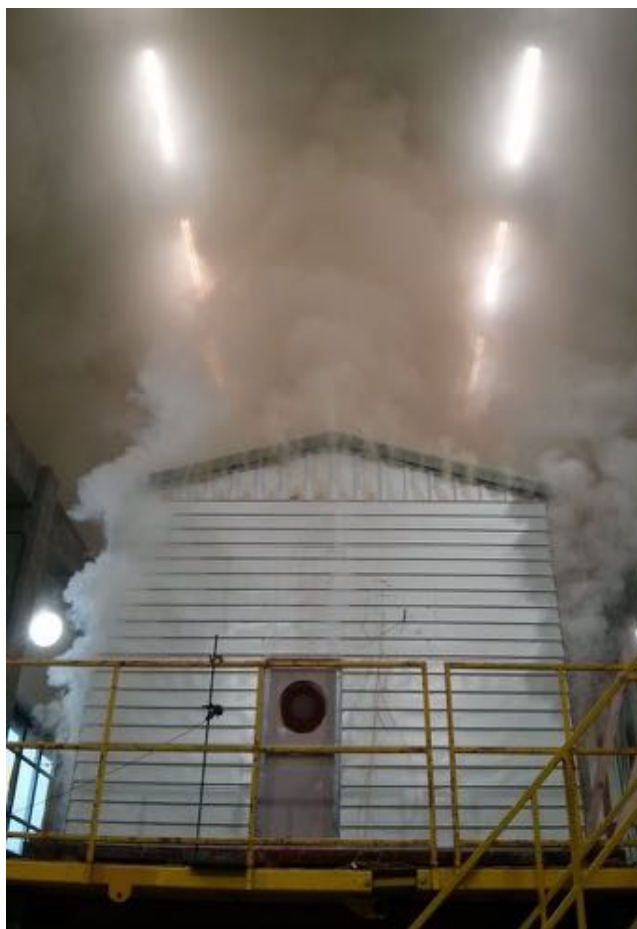
End wall, 16 minutes

- Approx. 16 minutes – ceiling system fails and falls into furnace

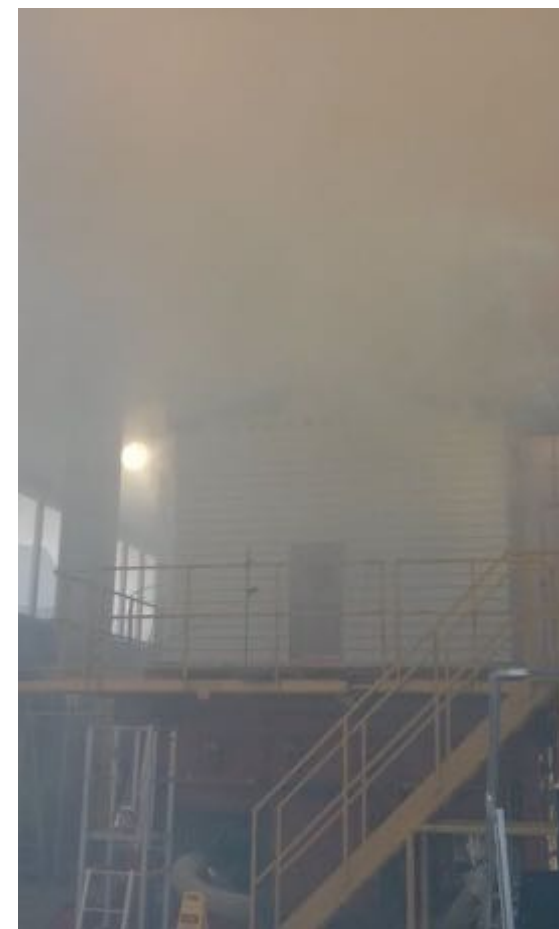
End wall, 19 minutes

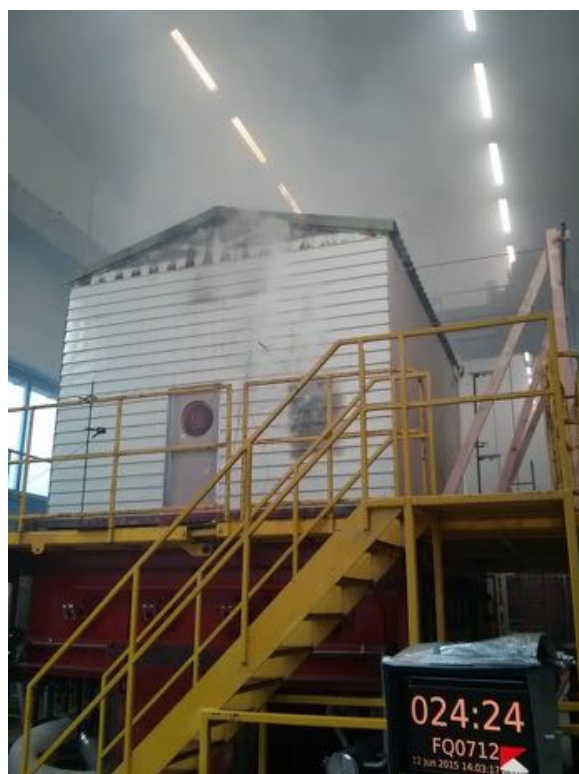
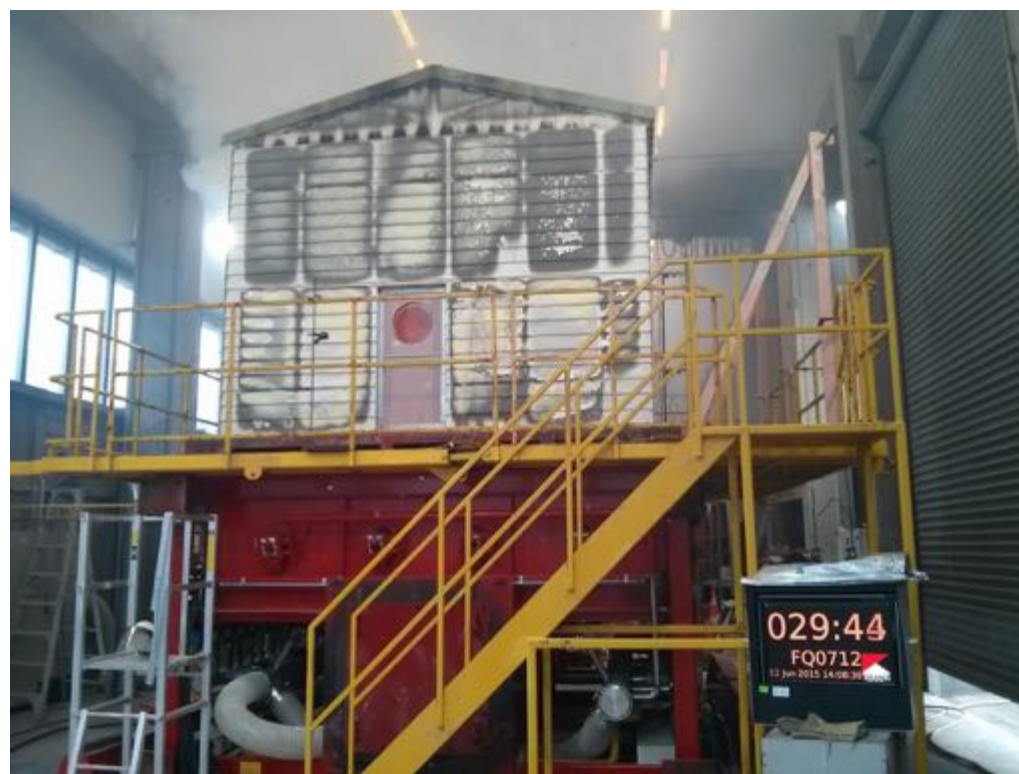
- 20 minutes – evidence of wall lining failure
  - Small deflections in fire-rated wall
  - Furnace pressure reduced, to clear smoke
- 25 minutes – notable deflection in firewall
- 30.5 minutes – Run-away deflection, furnace shut-off

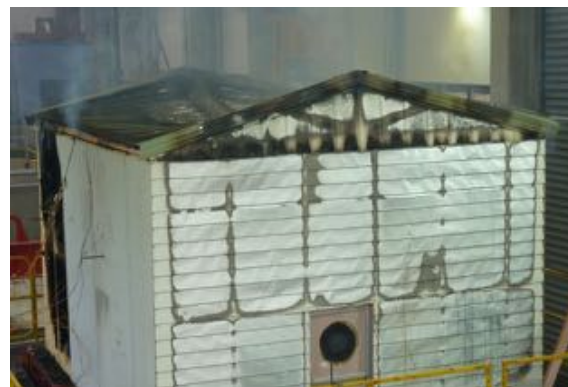
After fire - roof sagging, no support from roof truss

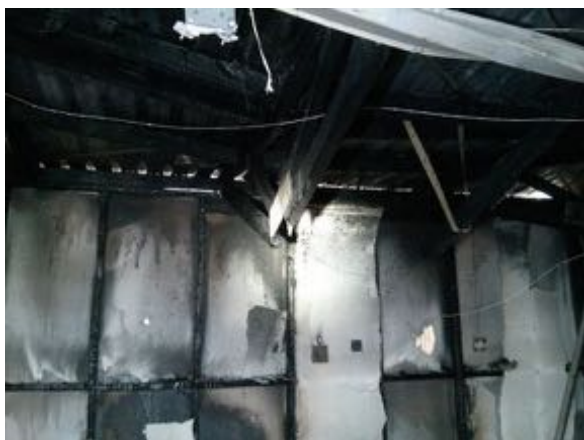
'Centre' roof truss

- Failure of spliced connection
- Roof sagging, no support from roof truss
- Walls remain upright (note: no lateral load)

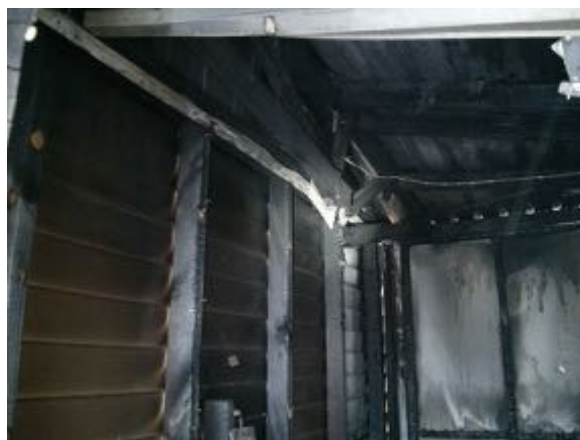
'Free' roof truss

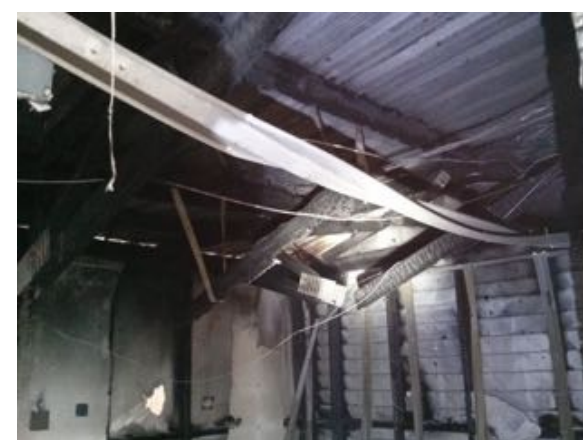
'Fixed' roof truss

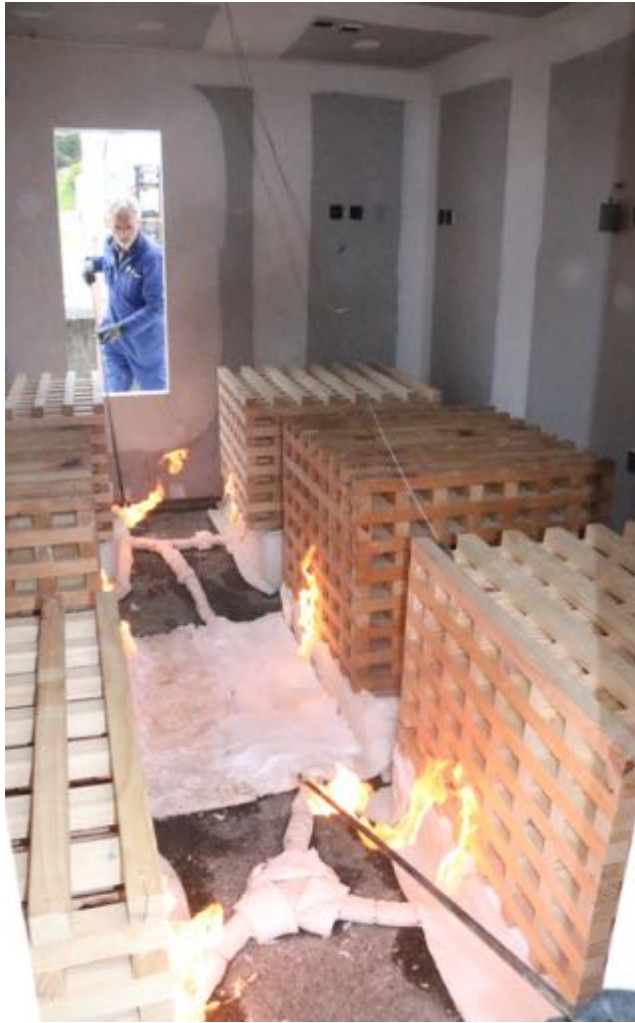
Ignition of cribs,  $t = 0$  min

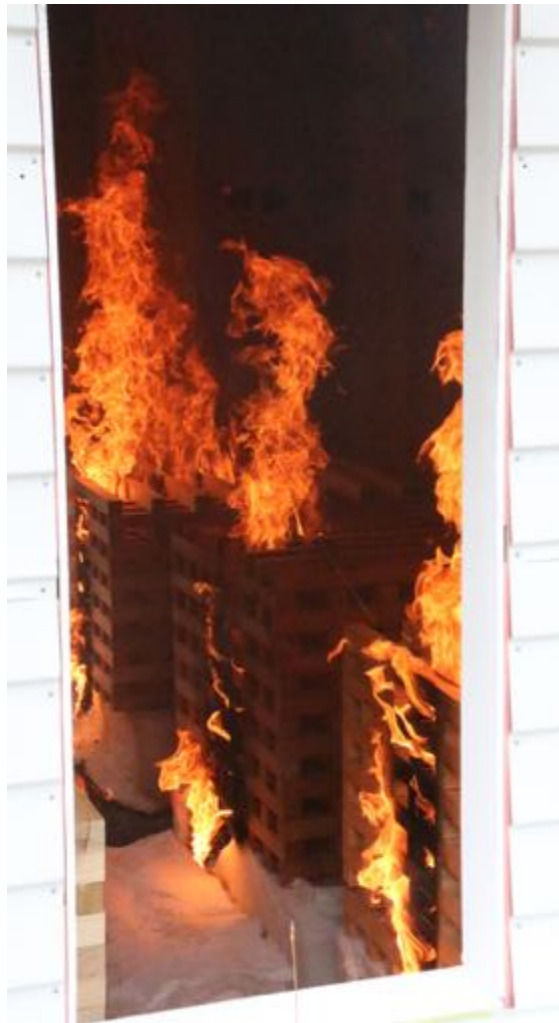
Fire growth,  $t \approx 3$  min

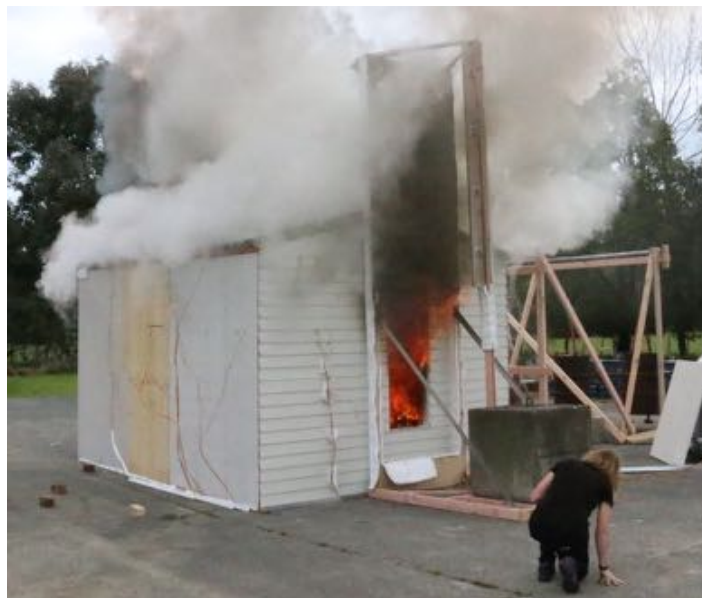
Approx. time of ceiling failure,  $t \approx 13$  min

Element	Natural fire experiment observed time [min]	Equivalent failure time exposed to standard time-temperature curve using cumulative radiant energy comparison [min]	Furnace test observed time [min]
Ceiling lining	12	17	16
Fire-rated wall lateral stability failure	28	33.5	30.5
Fire-rated wall insulation failure	33	39	Did not occur

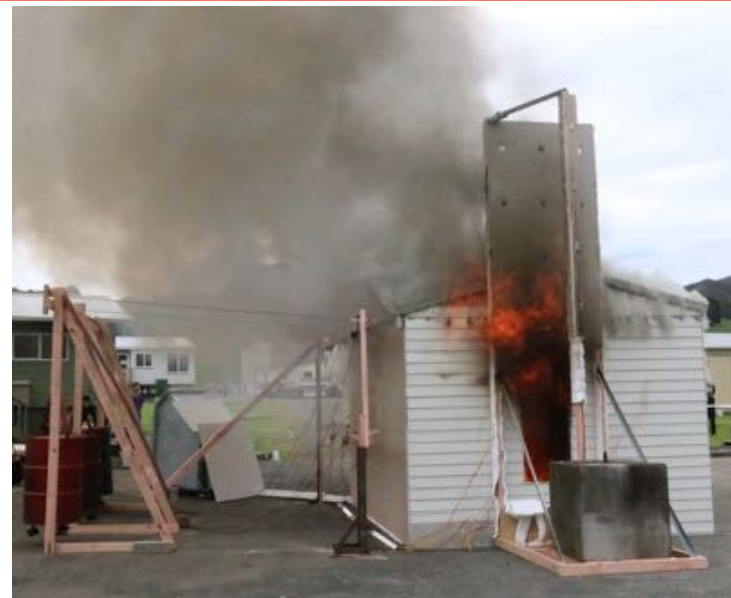
External flaming visible,  $t \approx 16$  min

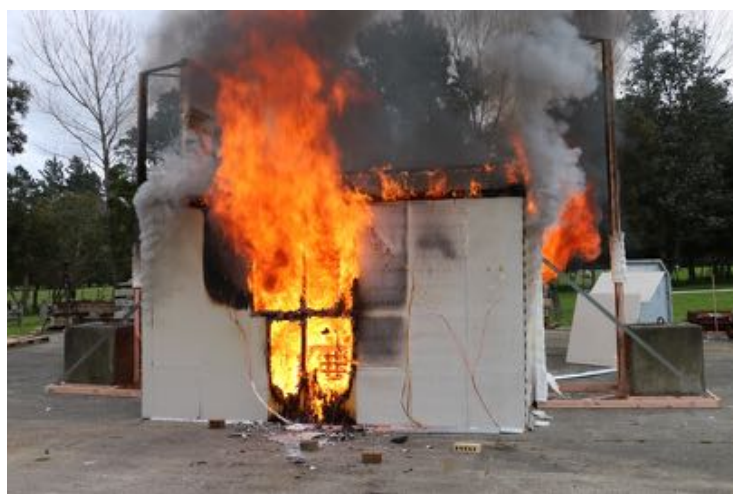
Non-rated wall,  $t \approx 28$  minutes

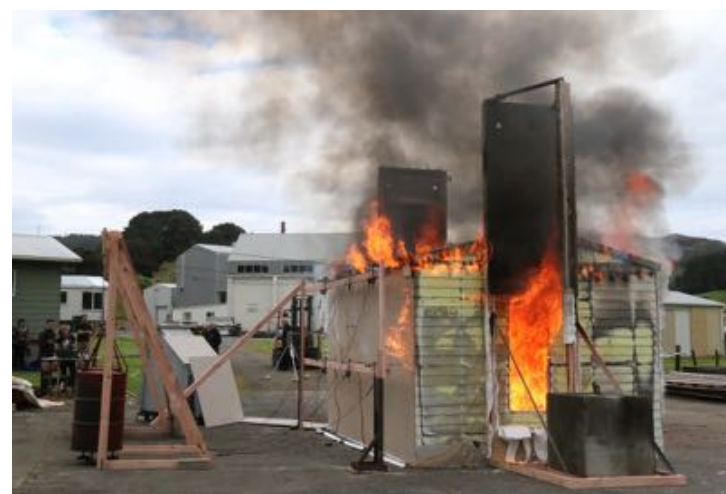
Fire-rated wall failed under lateral load & roof partially collapsed, photo at  $t \approx 30$  min

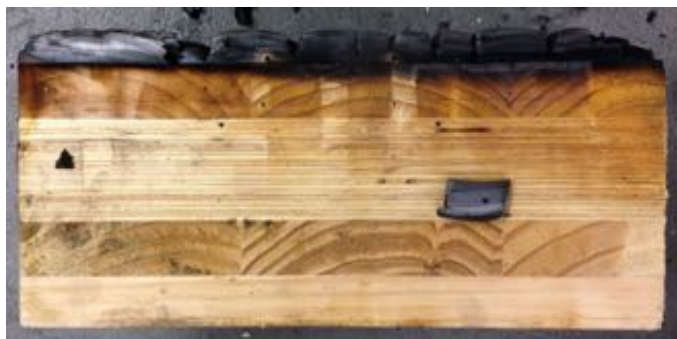
Typical char profile of sample before removing the char layer

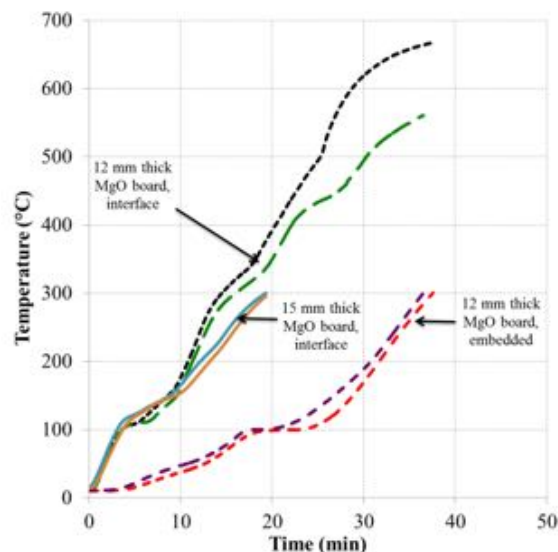
Temperature profiles for two 12 mm and 15 mm MgO board at 65 kW/m<sup>2</sup>

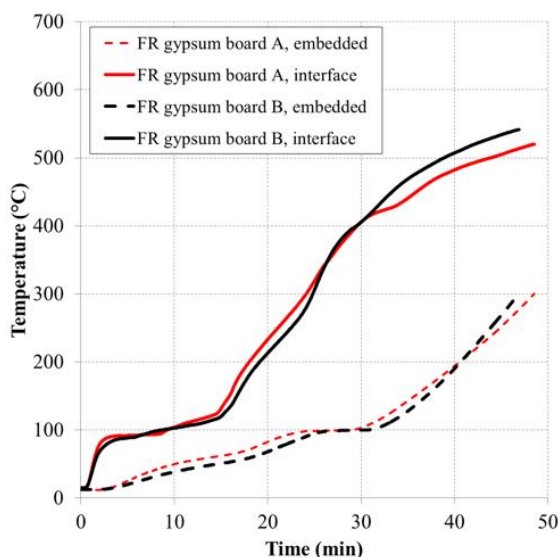
Temperature profiles for 13 mm thick FR gypsum boards at 65 kW/m<sup>2</sup>

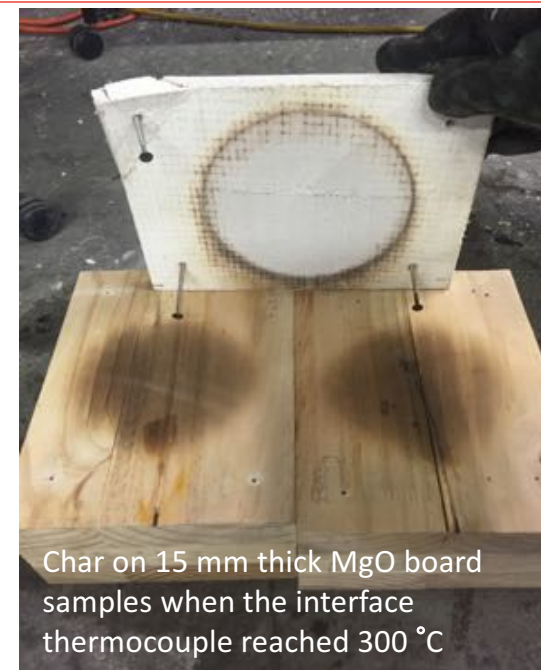
Char on 15 mm thick MgO board samples when the interface thermocouple reached 300 °C

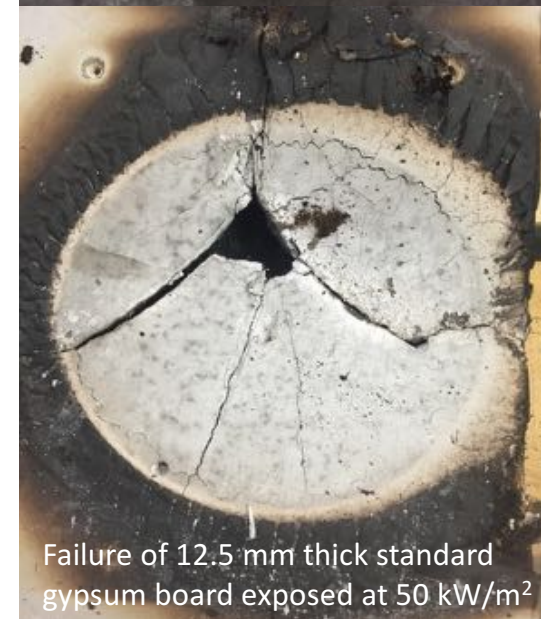
Failure of 12.5 mm thick standard gypsum board exposed at 50 kW/m<sup>2</sup>

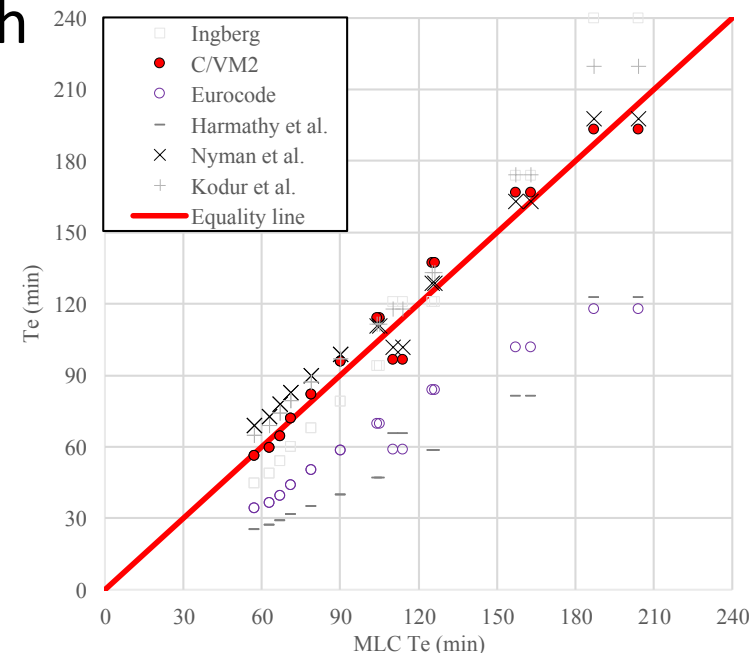
Comparisons between MLC and existing time equivalence methods for reinforced concrete beams

- New equivalent fire severity approach using the minimum load capacity (MLC) for structural adequacy of
  - protected/unprotected steel
  - reinforced concrete
  - composite steel and concrete
  - (maybe timber)
- Obtain MLC of a member under a compartment fire exposure using thermal and mechanical response models
- Derive  $T_e$  from the equivalent time it takes for the same member to reach this minimum capacity when exposed to the standard fire

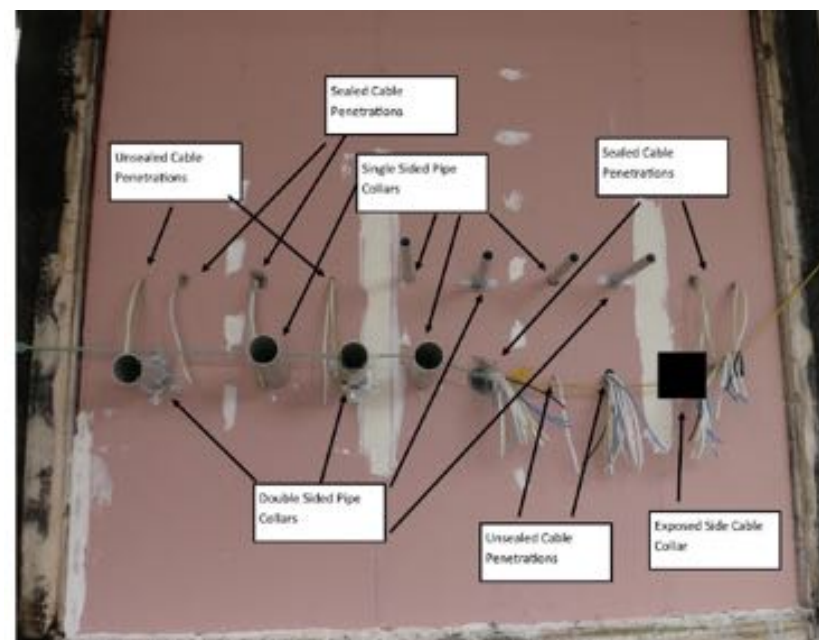
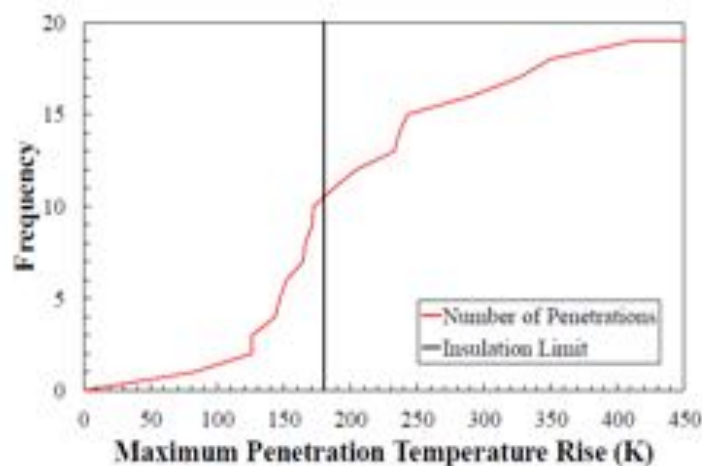
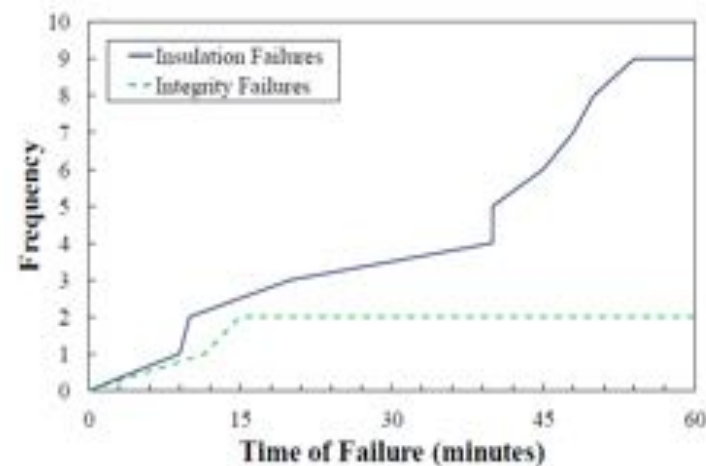
# Performance of passive fire protection defects exposed to a standard fire test

- Inadequate fire stopping of penetrations found during building renovations
- Standard fire exposure tests to 60 min on different defect types
- A total of 9 out of 19 failed the insulation criteria and 2 also failed the integrity criteria
- The two integrity failures that occurred were on the two penetrations that failed on insulation within the first 10 min
- More tests planned
